REPLACING TIMING CHAINS, TENSIONERS AND GUIDES ON A MKIV 12v VR6

The following DIY outlines the procedure for replacing timing chain parts on a MKIV 12v VR6 engine.

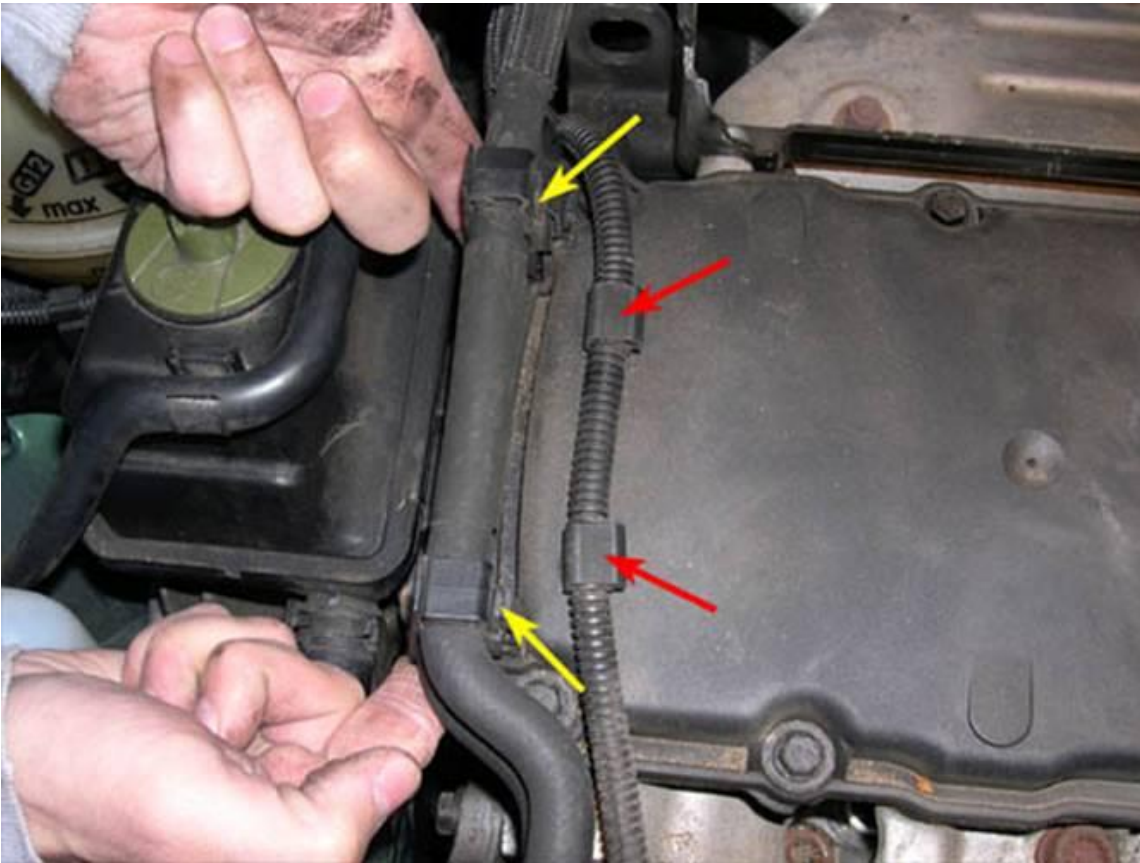
1. Unclip the fuel lines (yellow arrows) and rear knock sensor wire (red arrows) from the top of the valve cover, as shown in the picture below (this may not be necessary on all engines).

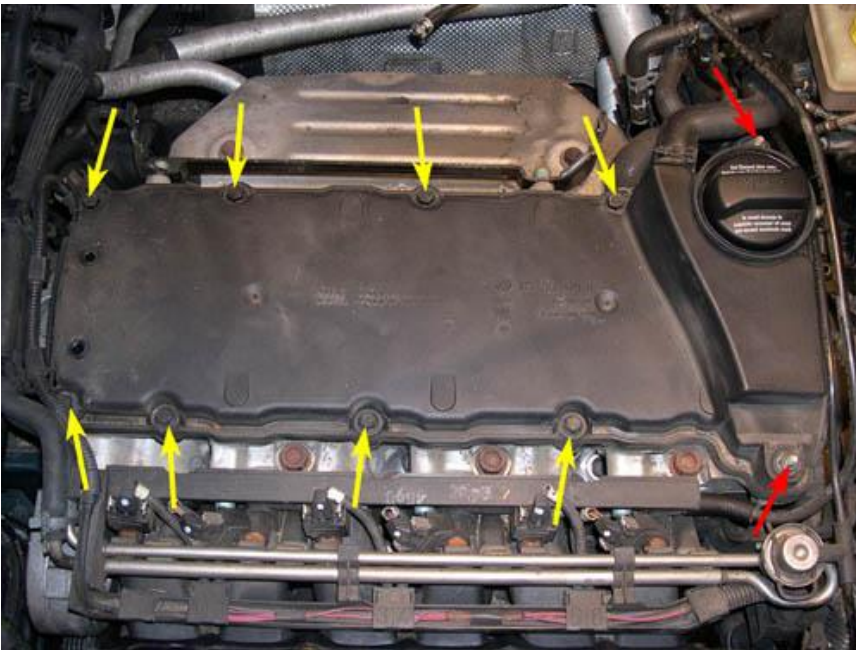
2. Loosen and/or remove the ten (10) 10mm bolts/nuts that secure the valve cover. On a MKIV, there are 8 captured bolts (yellow arrows in picture below) and 2 nuts on posts (red arrows in picture below). I believe that all ten are nuts on posts on other VR6 engines, but I may be wrong. Once the valve cover is unsecured, pull it up and off of the head, being careful not to damage the cover gasket (it will be reused).

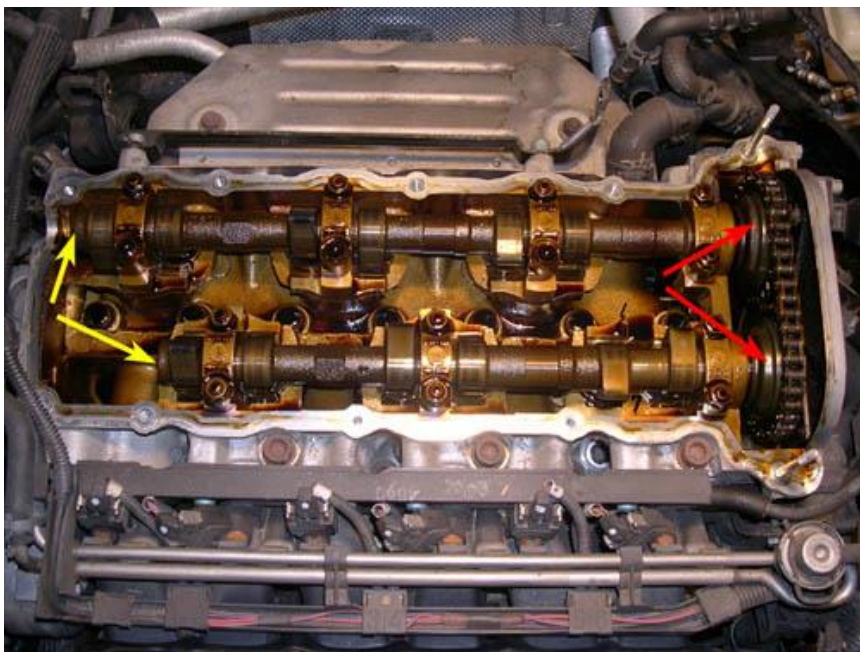
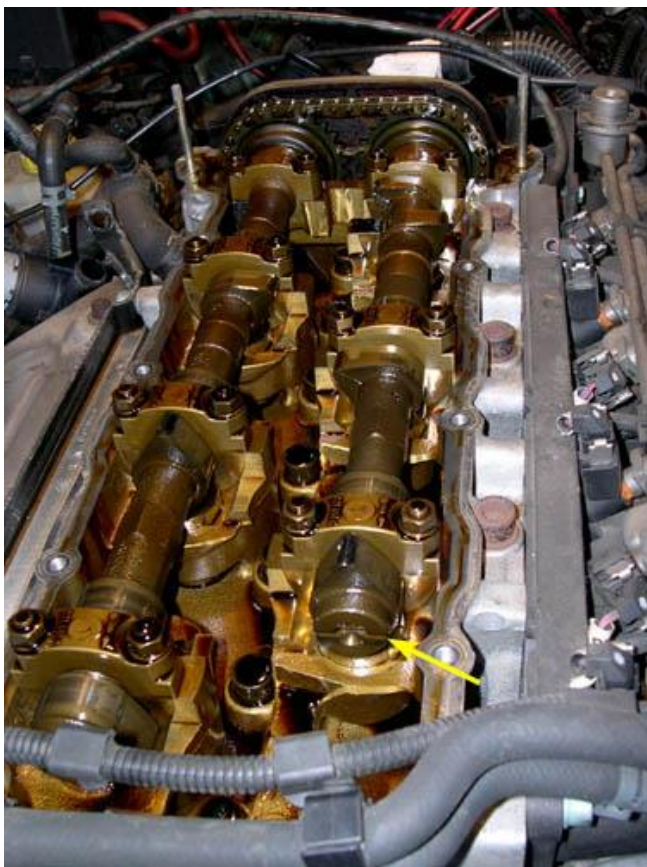
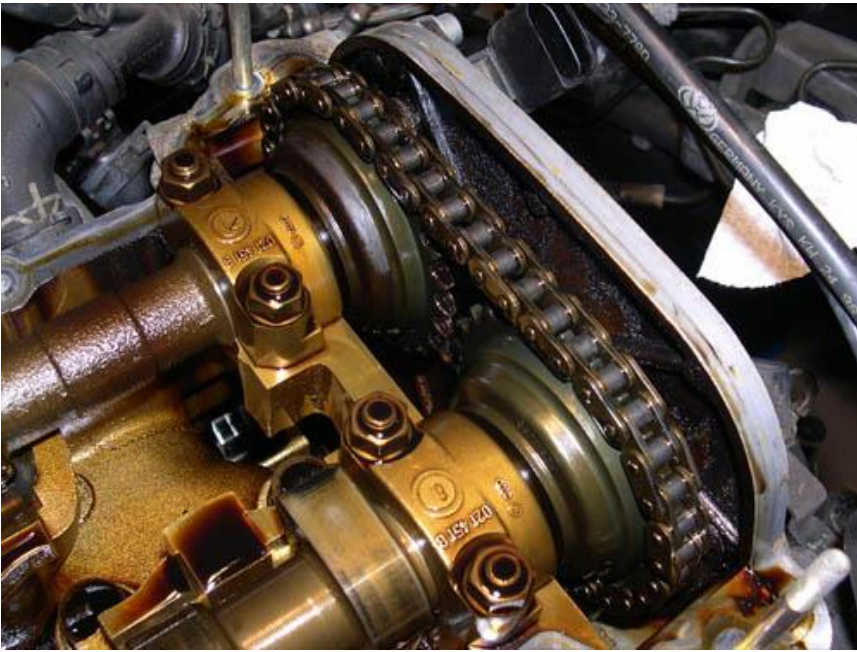
3. The images below show the two camshafts. On the passenger's end are grooves that are used for timing the engine (yellow arrows) and on the driver's end are the camshaft sprockets and upper timing chain.

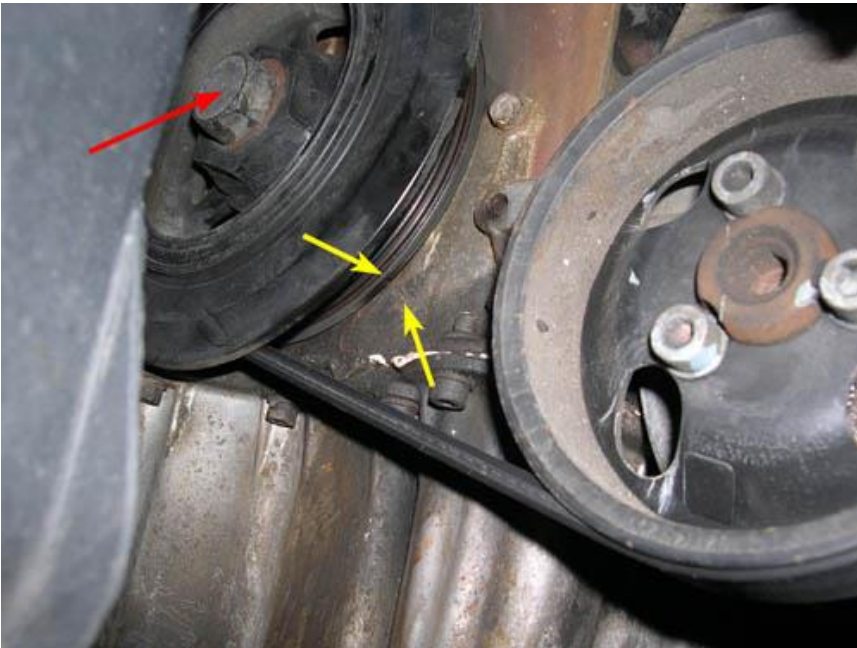
5. Crank the engine to Cylinder #1 TDC (top dead center) by slowly hand-turning the crankshaft pulley (red arrow in picture below) clockwise with a 27mm wrench or socket until the little notch on the inner flange of the pulley lines up with the timing mark on the block (yellow arrows in picture below).

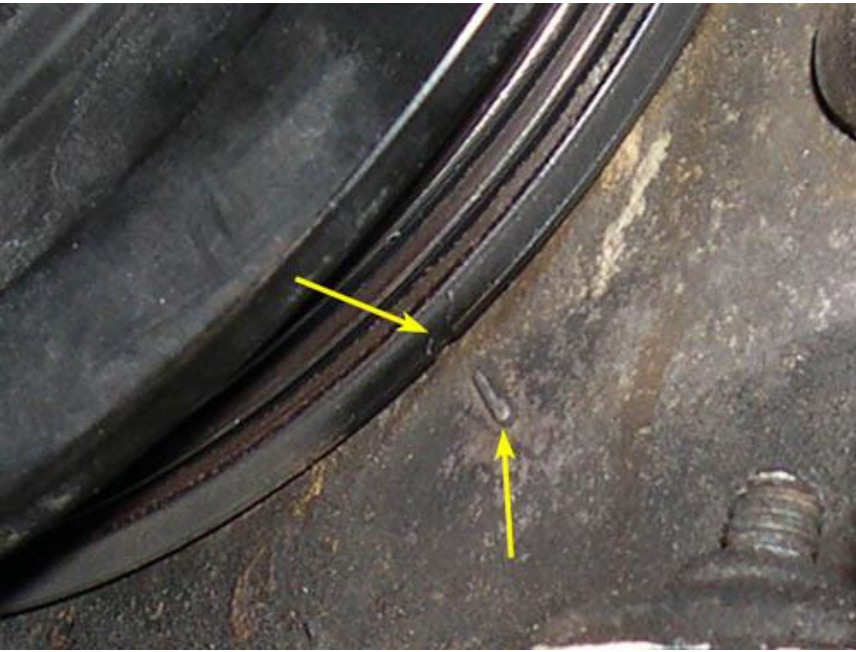
6. The picture below shows a close-up of the notch and timing mark that need to be lined up to set the engine at Cyl. #1 TDC.

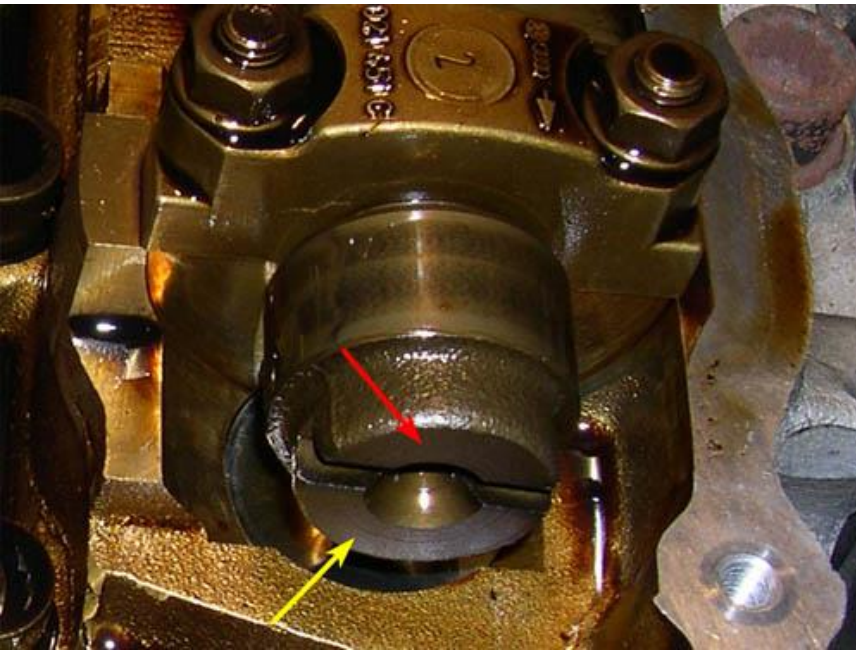
7. Once the notch and timing mark are lined up, check the groove on the end of one of the camshafts. The groove should be above the centerline of the shaft - i.e., there should be more material below the groove (yellow arrow in the picture below) than above the groove (red arrow in picture below). If the opposite is true, then the camshafts are 180° out of phase. Rotate the crankshaft one full revolution and line up the notch and timing mark again to set the camshafts for Cyl. #1 TDC (remember, two rotations of the crankshaft equals one rotation of the camshafts).

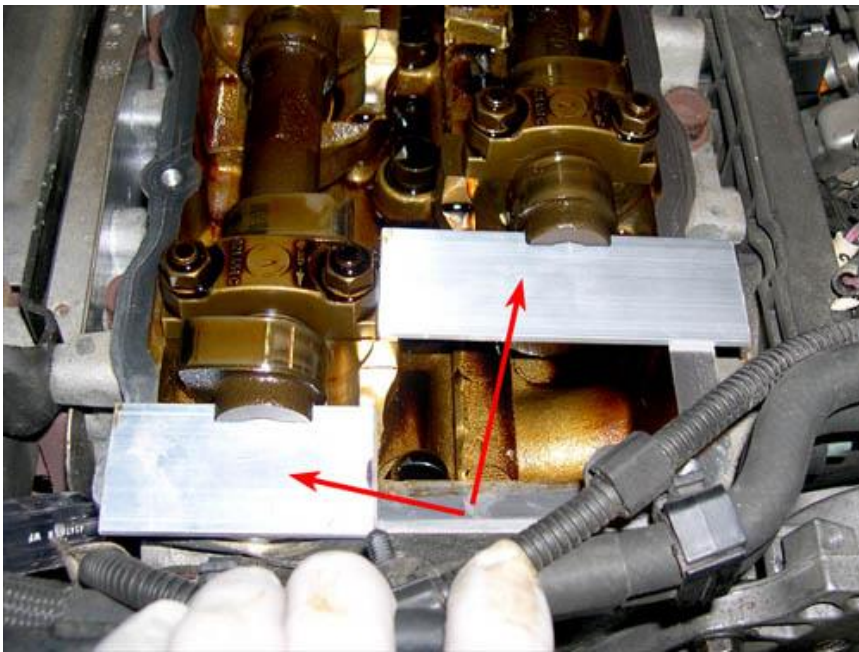
8. If everything is lined up properly and the engine is at Cyl. #1 TDC, you should be able to slide the camshaft locking tool (VW tool #3268) into the grooves. Instead of using the VW tool, I just used two 1/8" thick pieces of Al plate (purchased at Lowe's) to lock each camshaft individually, as shown by the red arrows in the picture below. You can use pretty much any 1/8" thick metal or dense plastic plate for this purpose.

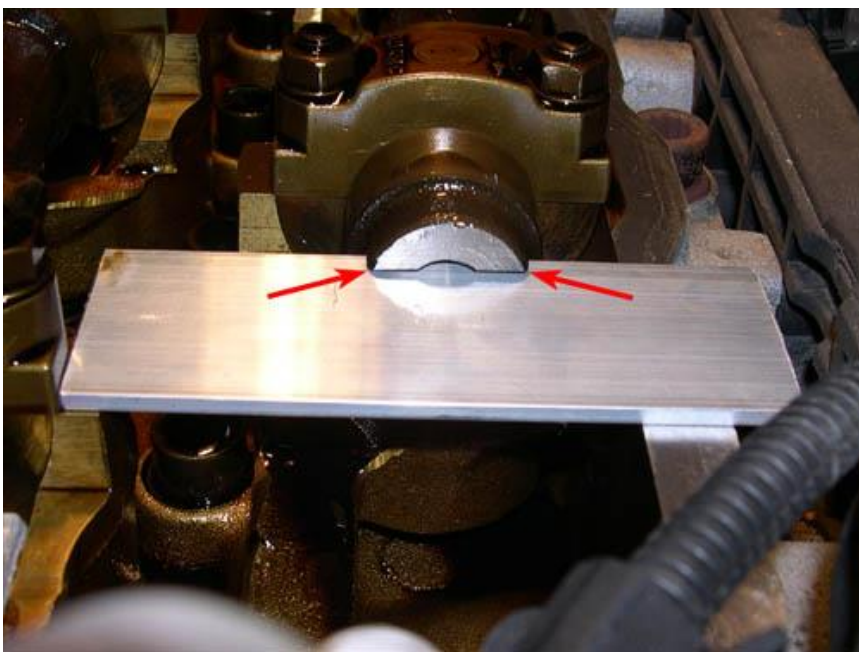
9. If the engine is timed correctly, the camshaft tool(s) (VW or improvised) should slide into the groove easily and should be exactly parallel to it. The picture below shows that the gaps between the groove and tool on either side of the camshaft should be equal.

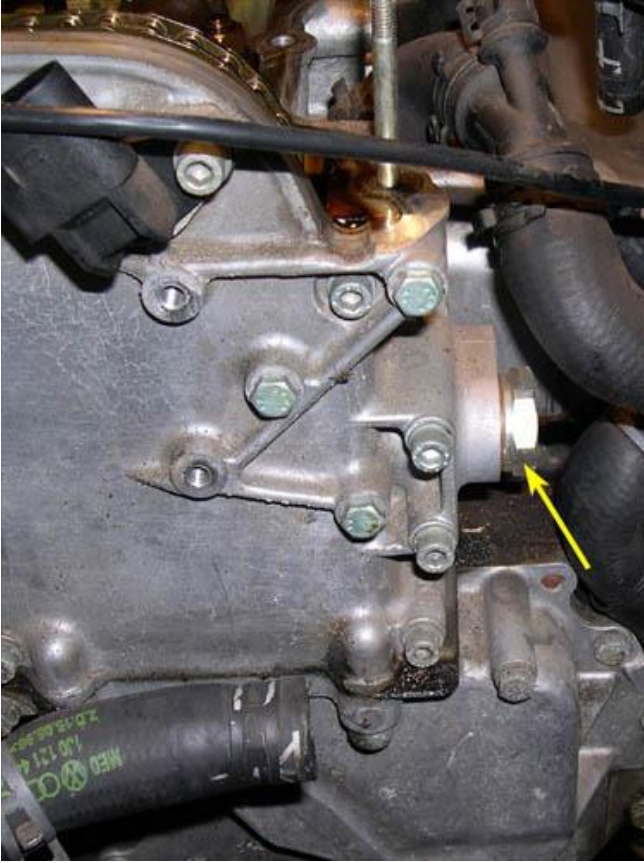
10. Remove the upper tensioner bolt (yellow arrow in the picture below) from the back edge of the upper timing chain cover using a 27mm wrench or socket.

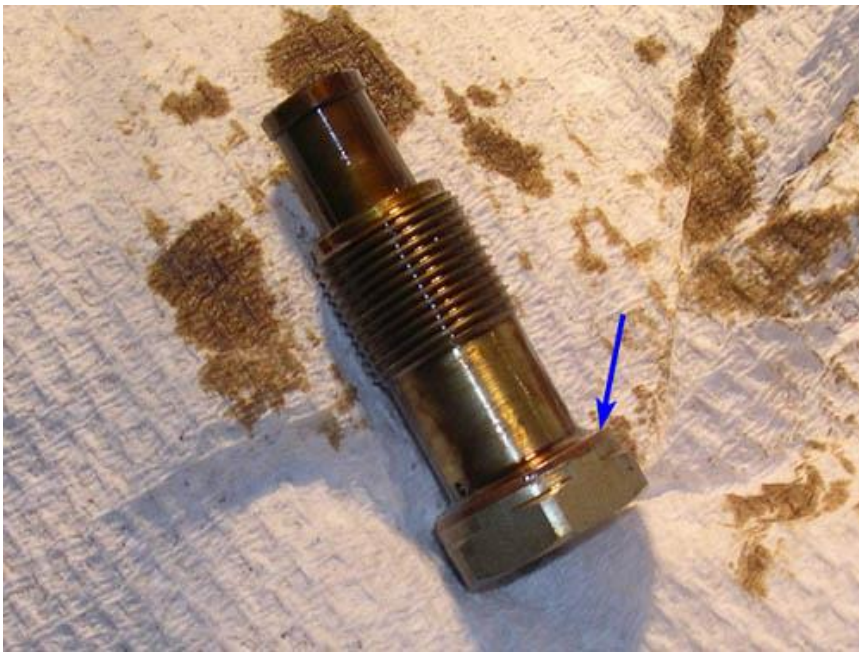
11. The picture below shows the newer style upper tensioner bolt. There should be a copper crush washer (blue arrow) present to seal the bolt against an oil leak. (**Note:** Even though the tensioner bolt and crush washer have separate VW part #s, the parts are one piece on the newer style tensioner.)

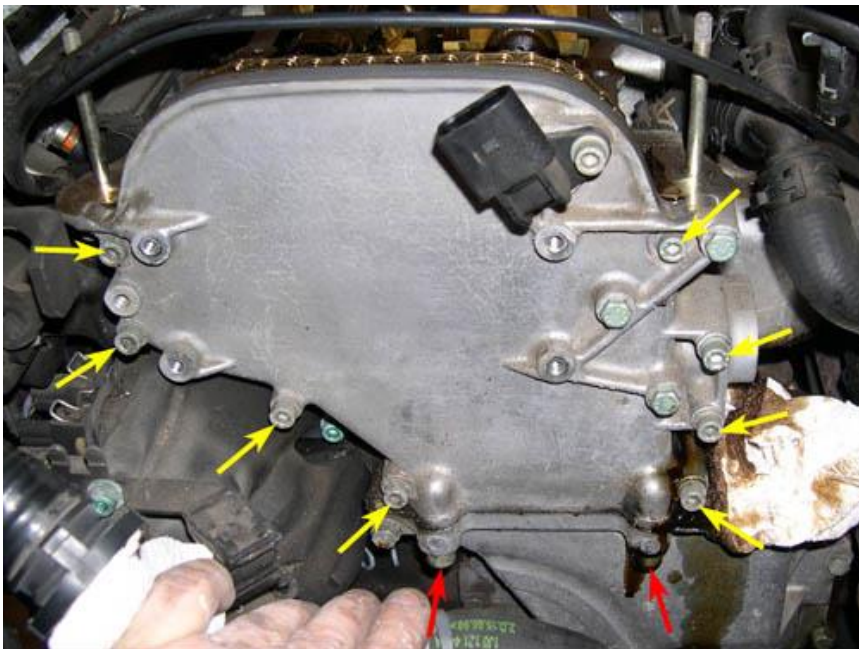
12. Remove the bolts that secure the upper timing chain cover. There are eight (8) 5mm hex bolts (yellow arrows in picture below) that secure the cover to the head and two (2) 6mm hex bolts (red arrows in picture below) that secure the upper and lower timing chain covers to each other (with part of the headgasket between them - this will be covered in more detail below).

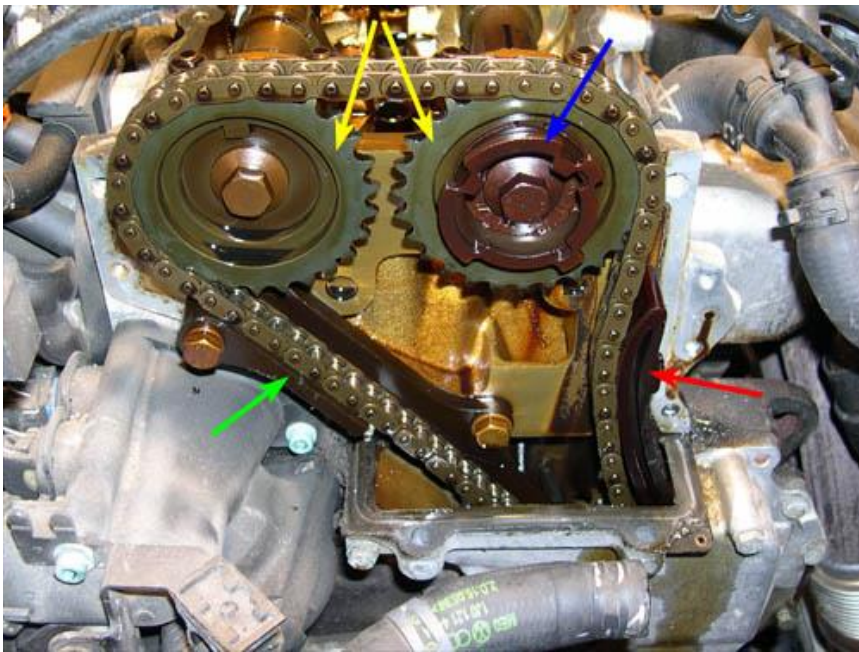
14. With the upper timing chain cover off, you should be able to see most of the upper timing chain parts, as shown in the picture below. The yellow arrows point to the two camshaft sprockets, which are secured to the camshafts with 15mm bolts. The blue arrow points to the shutter wheel on the rear sprocket that is used by the camshaft position sensor (this wheel may be slightly different on earlier model VR6s). The green arrow points to the upper guide rail and the red arrow points to the upper tensioner rail.

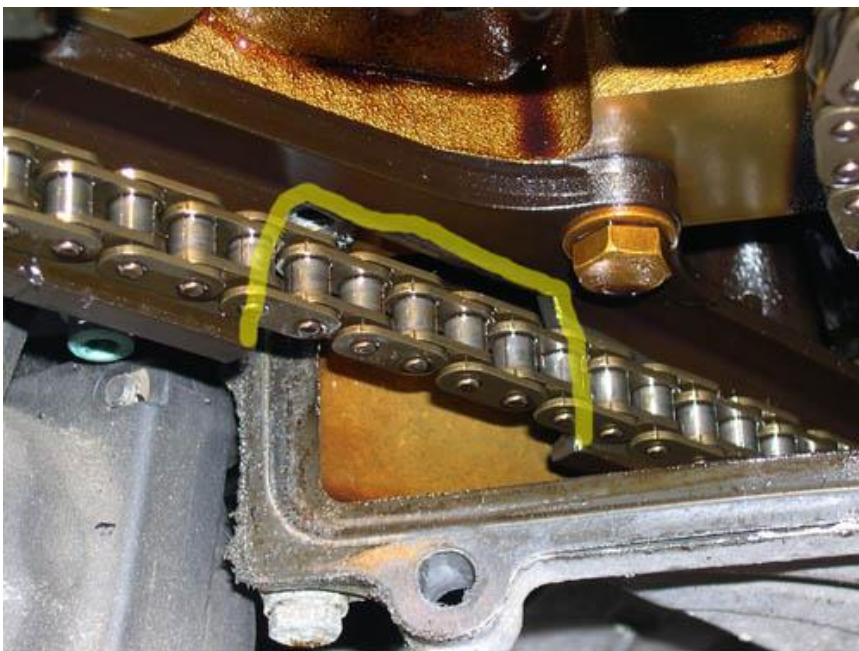
15. The picture below shows a close-up of my original upper guide rail. The yellow shading shows the location of a piece that broke off and was causing the rattling noise heard in the sound clip in the link above. 🤔

Aside from the upper guide rail that was snapped in a bunch of pieces and was causing a loud rattling noise between 1000 and 1200 RPMs, the rest of the parts show extremely little wear considering they had been in use for almost 150k miles. 🤖

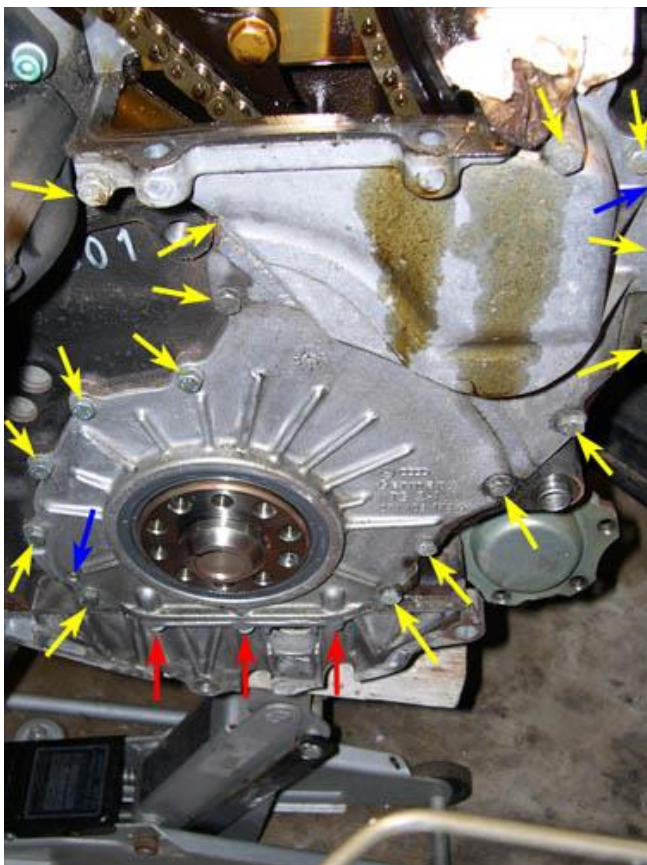
17. Remove the bolts that secure the lower timing chain cover. There are sixteen (16) 10mm bolts (yellow arrows in picture below) that secure the cover to the block and three (3) 5mm hex bolts (red arrows in picture below) that secure the lower timing chain cover to the oil pan. The blue arrows indicate the position of guide pins used to locate the cover when reinstalling it. **NOTE: It has been pointed out by [ubercruizinvr6](#) that the lower part of the thermostat housing on pre-MKIV VR6s needs to be loosened/removed in order to remove the top front lower timing chain cover bolt (above the '01' in the picture below) - see pages 3 and 4 of this DIY thread and/or the DIY UPDATES section below for more info.**

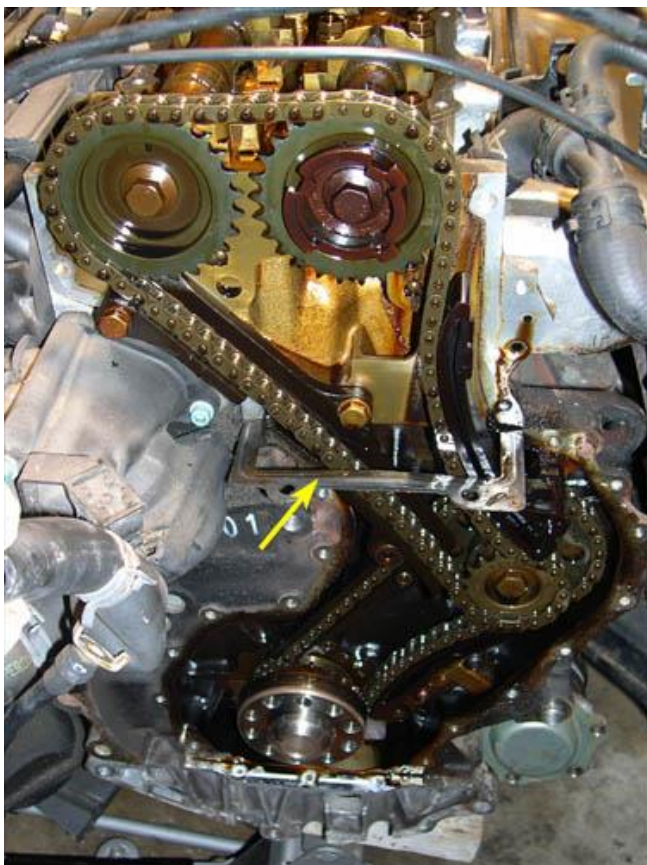
19. With the upper timing chain cover off, you should be able to see all timing chain parts, as shown in the picture below. The yellow arrow points to the part of the headgasket that normally resides between the two timing chain covers, but is now completely unprotected. Be extra careful not to damage/bend the gasket during the replacement procedure below.

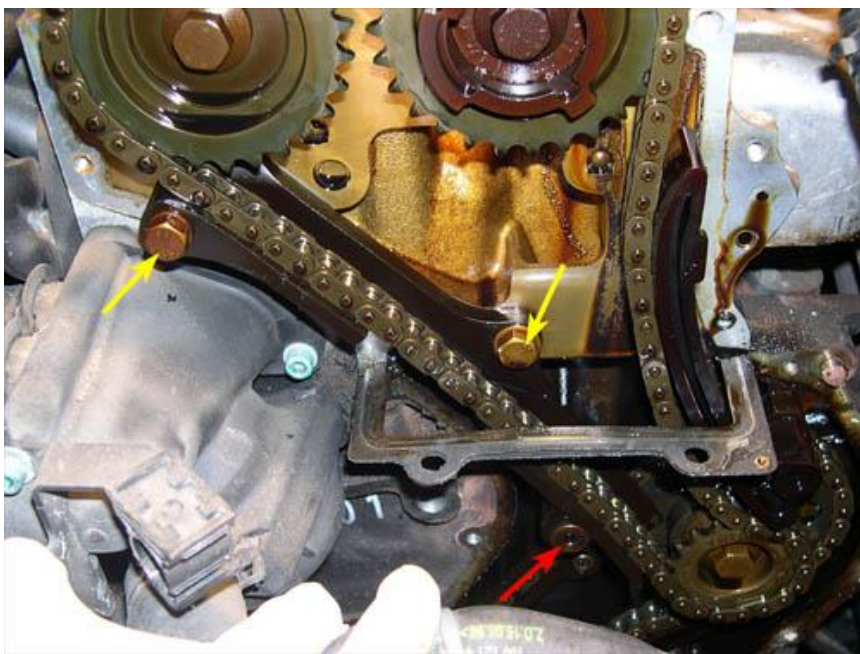
20. Remove the upper guide rail by removing the two (2) 13mm bolts (yellow arrows in picture below) and then sliding the rail up and off of the lower guide post (red arrow in picture below). You do not need to remove the guide pin. (Note that the guide pin resides behind the lower chain cover - I suspect that VW used a guide pin instead of a bolt here so that the guide could be replaced without having to remove the lower cover, and consequently, the tranny, clutch, etc).

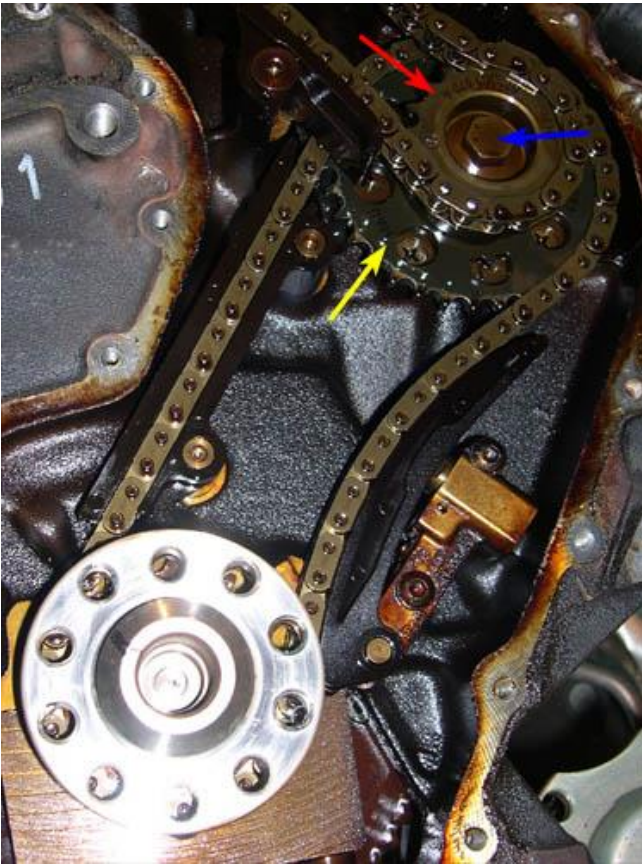
22. In order to remove both the upper and lower timing chains, it is necessary to create some slack in the chains. The easiest way to accomplish this in both chains is to remove the intermediate sprockets. In the picture below, the yellow arrow points to the inner intermediate sprocket and the red arrow points to the outer intermediate sprocket. To remove the sprockets, remove the 15mm bolt (blue arrow in picture below) that secures the sprockets to the intermediate shaft. In order to do this, it is necessary to counterhold the crankshaft to keep it at Cyl. #1 TDC. You can use one of the special VW tools to do this, or you can just have a friend counter hold the crankshaft pulley with the 27mm wrench or socket and a long breaker bar. The intermediate shaft bolt is torqued on fairly tight (74 ft-lbs or 100 N-m), so it will take a good amount of force to loosen it. If the crankshaft accidentally moves slightly while loosening the bolt, turn the crankshaft back to Cyl. #1 TDC BEFORE removing the intermediate bolt and sprockets. (**Note:** Leave the camshaft locking tool in place while loosening the intermediate shaft bolt. As long as the crankshaft does not move significantly, there is no harm in leaving the tool in the camshaft grooves.)

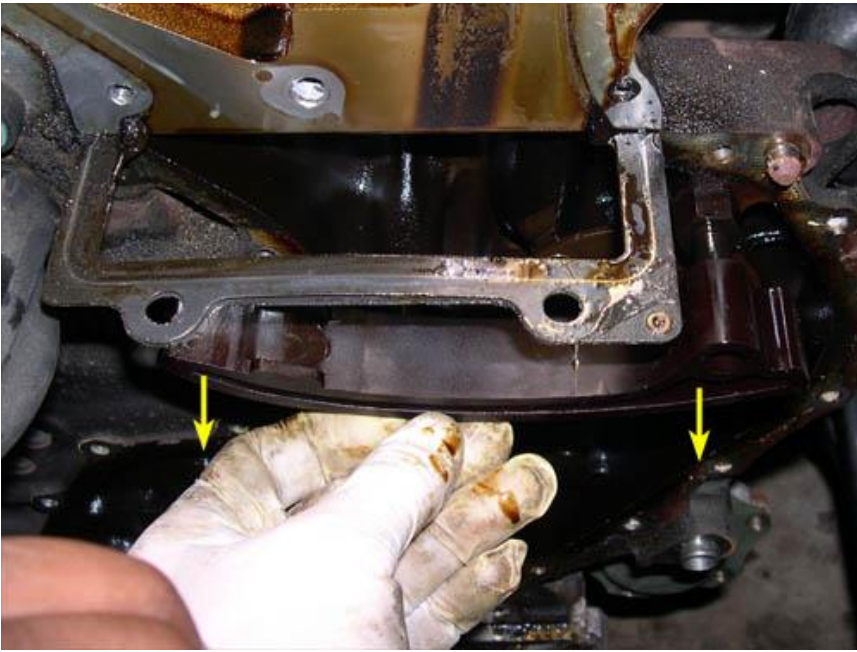
25. To remove the upper tensioner rail, simply slide it off of the pivot pin, as indicated by the yellow arrows in the picture below. You do not need to remove the pivot pin.

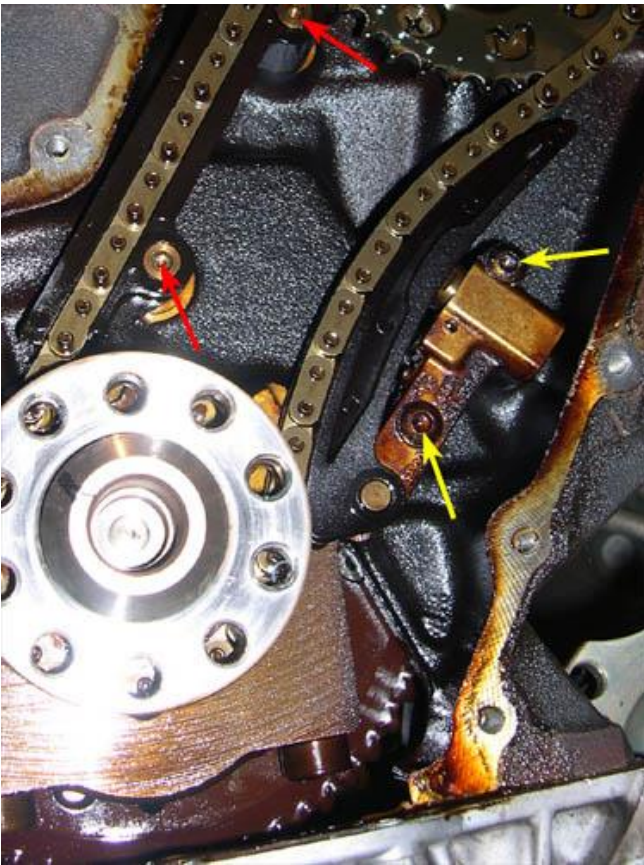
26. Remove the lower tensioner unit by removing the two (2) 5mm hex bolts indicated by the yellow arrows in the picture below (the tensioner will fully extend when removed if you don't hold the rail and body together or secure it with a U-clip like the one that comes with a new tensioner).

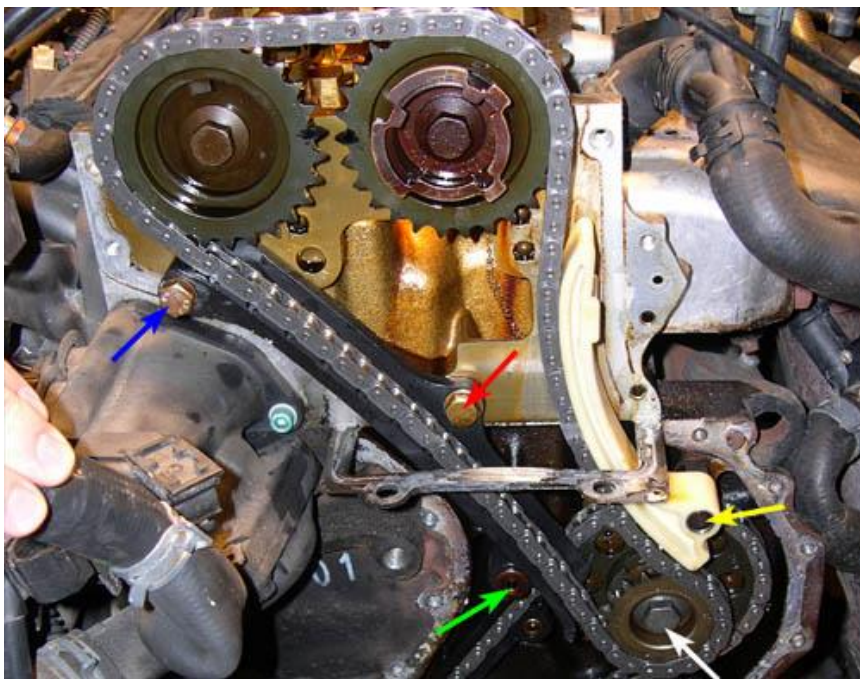
35. Slide the new upper tensioner rail onto its pivot pin (yellow arrow in picture below) and rotate the rail clockwise through the hole in the headgasket. Use a piece of tape or something similar to temporarily hold the rail in the upright position (remove the tape after the upper timing chain and outer intermediate sprocket have been installed). Next, install the new upper guide rail by sliding it onto its guide pin (green arrow in picture below) and then installing the two (2) 13mm bolts (red and blue arrows in picture below). Use Loctite (blue - med. strength) on the central, shorter bolt (red arrow) and torque both bolts to 15 ft-lbs (20 N-m).

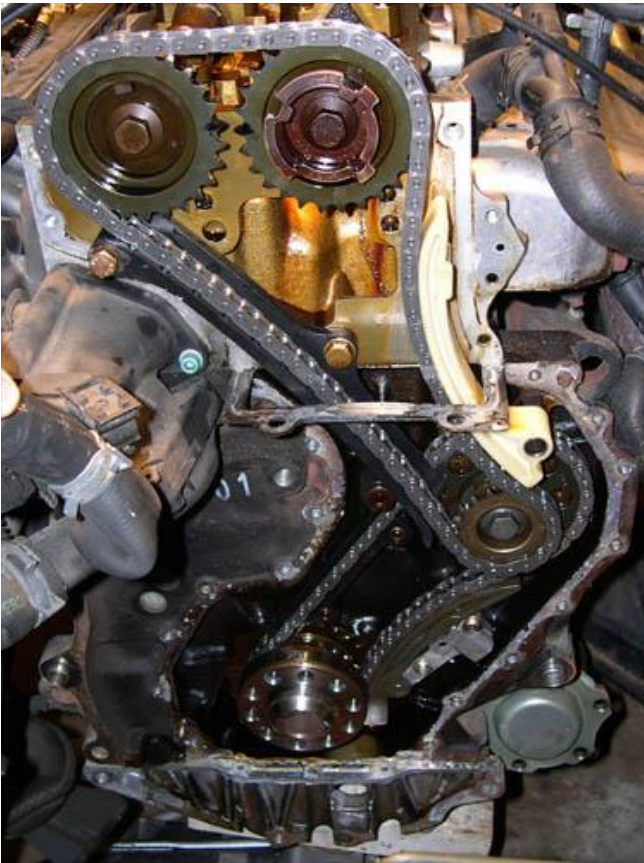
39. The new timing parts should now be correctly installed, as shown in the picture below.

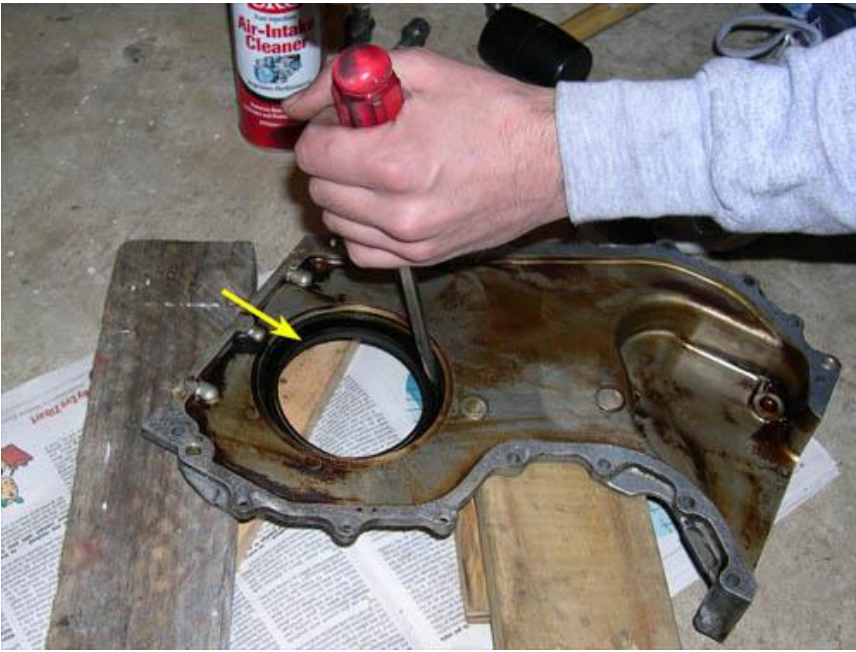
45. To remove the old rear main seal (yellow arrow in picture below), support the lower timing chain cover with a few pieces of wood with the inside surface of the cover facing up, as shown below. Using a screwdriver or other similar tool and a hammer, carefully pound the old seal out of the cover. The old seal may be in there tight, so you may have to pound pretty hard to get it out. Be careful not to mar the mating surface of the timing cover or the new seal may not seal properly when installed. Just take your time and pay attention and it should come out without any problems.

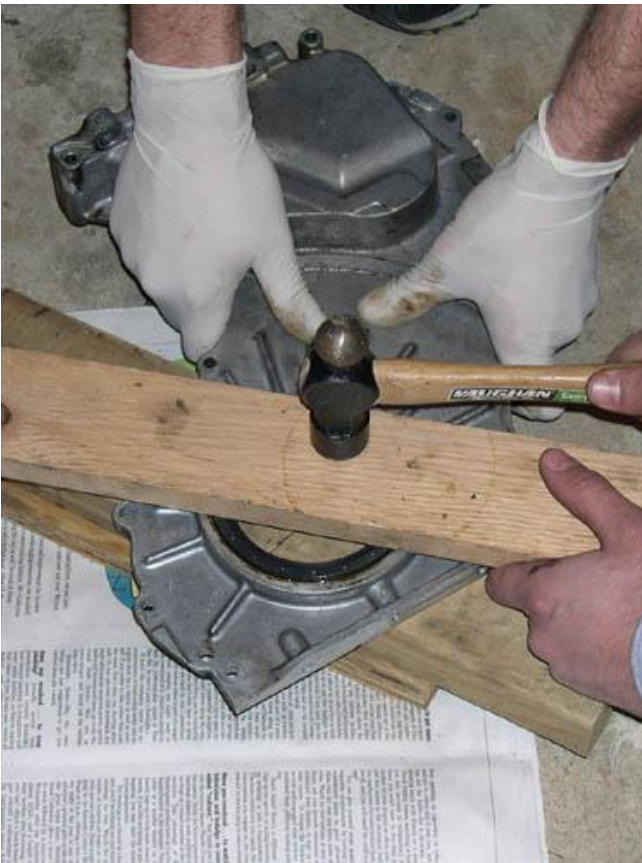
46. To install the new rear main seal, flip the timing chain cover over, apply some oil to the mating surfaces of the cover and seal and then carefully pound the seal into the cover using a hammer and a wide board, as shown in the picture below. Move the board around the perimeter of the seal while pounding to make sure that the seal goes in straight. The seal is installed fully when the outer edge of the seal lines up with the outer edge of the cover (at this point the board will no longer pound the seal in any further, so it's pretty much idiot-proof).

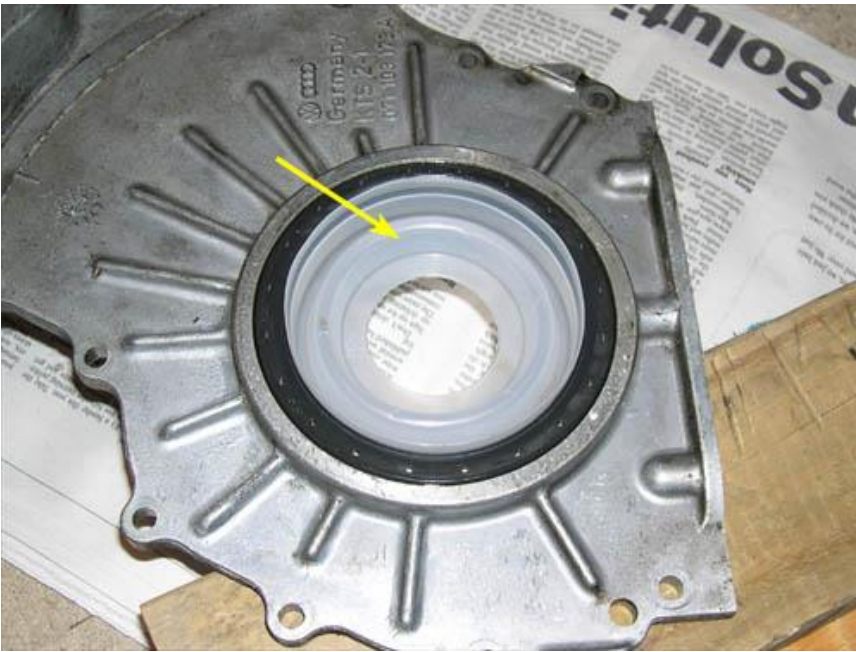
47. The picture below shows the new seal installed in the lower timing chain cover. Also shown is a plastic insert (yellow arrow) that is provided with the seal to make the installation of the seal around the crankshaft flange easier when installing the lower timing chain cover. (We tried to use this piece when installing the cover, but it actually got in the way and kept popping out of the seal prematurely. We eventually gave up and just installed the lower cover without it without any

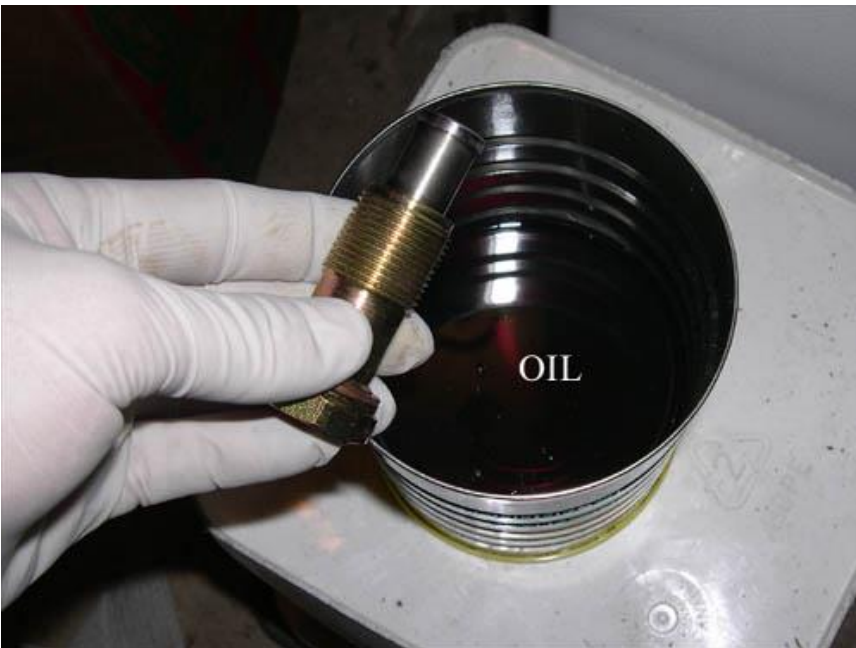
48. Before permanently installing the upper tensioner bolt, it is a good idea to bleed the air from it and fill it up with oil. Fill a coffee can or other container with about 4 inches of motor oil, as shown in the picture below. Place the tensioner bolt in the can with the plunger end down and the head end up (so that the feed hole is at the highest point). While submerged, press down on the bolt in the can to compress the plunger fully. This will force any air out of the tensioner. Release the tensioner while submerged to fill the tensioner with oil. Repeat this a few times until you're confident there is no more air in the tensioner. Leave the tensioner bolt in the oil until it's ready to be installed.

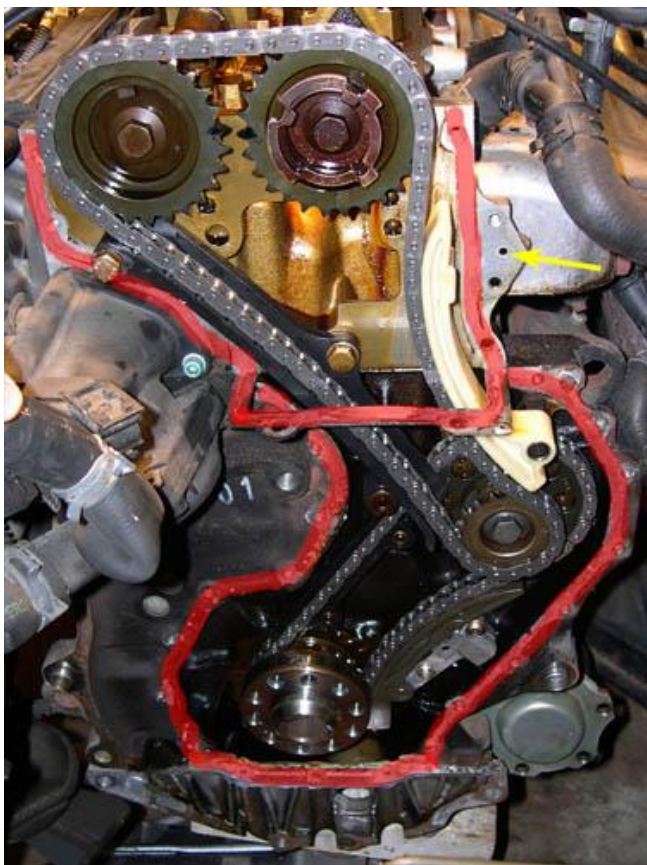
49. Apply RTV sealant to the mating surfaces of the timing chain covers. These surface are what contact the red shaded areas in the picture below (don't forget about on top of the oil pan and on both the top and bottom of the headgasket. Use ultra-grey import RTV to seal the timing chain covers since it is O2 sensor-safe. Make sure that the oil feed hole for the upper tensioner bolt (yellow arrow in picture below) will not be clogged with RTV when the upper cover is installed.

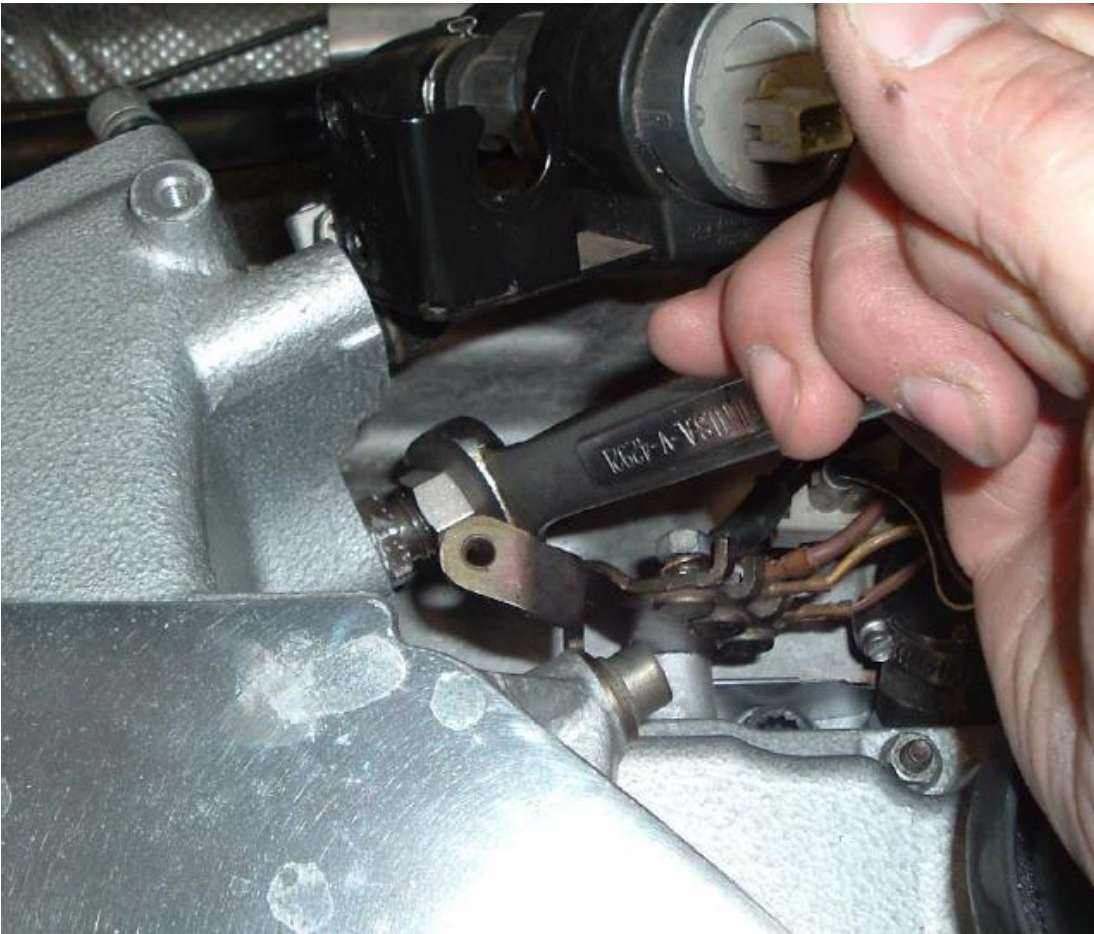
To remove the valve cover, you will have to unbolt the EGR assembly from it. It is attached using two 10mm hex head bolts that go through a wiring harness support as well as the EGR bracket. You can see one of the bolts in the pic, the other is behind the vacuum hose.

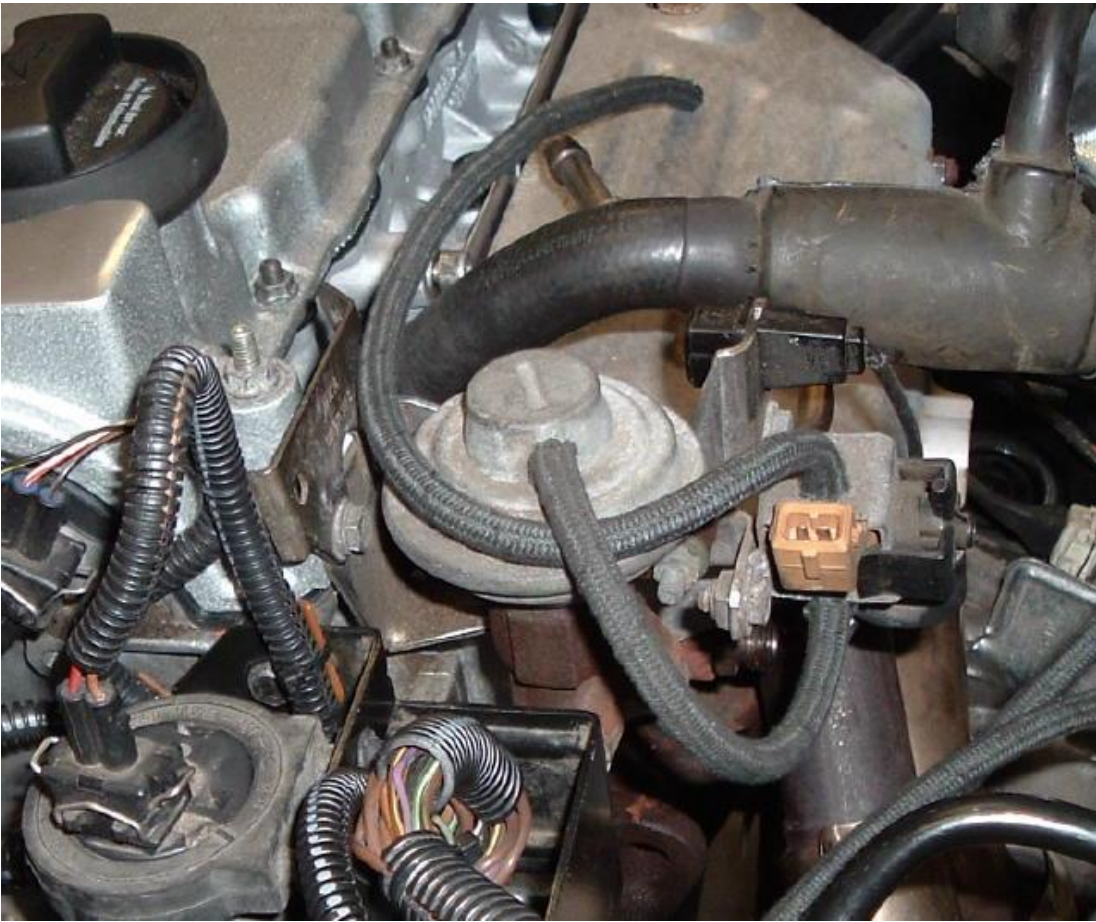
As you can see, you will need to disconnect the engine wiring in the upper area so that the harness can be folded back to the driver's side out of your way.

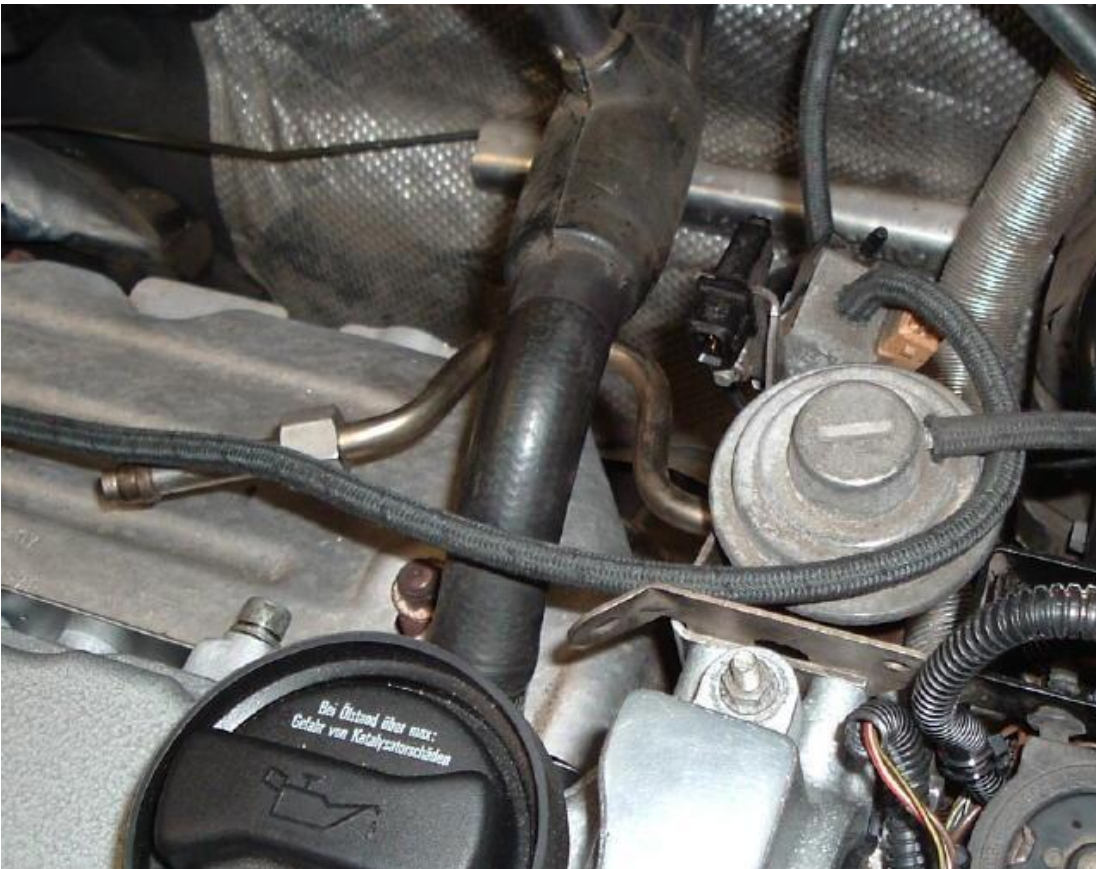
There is very little room so you will have to use the open end of your 10mm wrench to back these two bolts out together a little at a time. There are also two bolts holding the valve to the bracket, but they are no piece of cake either and they would open a gas seal at the intake tube. So stick with the two bolts up front.
