REPLACING TIMING CHAINS, TENSIONERS AND GUIDES ON A MKIV 12v VR6

The following DIY outlines the procedure for replacing timing chain parts on a MKIV 12v VR6 engine.

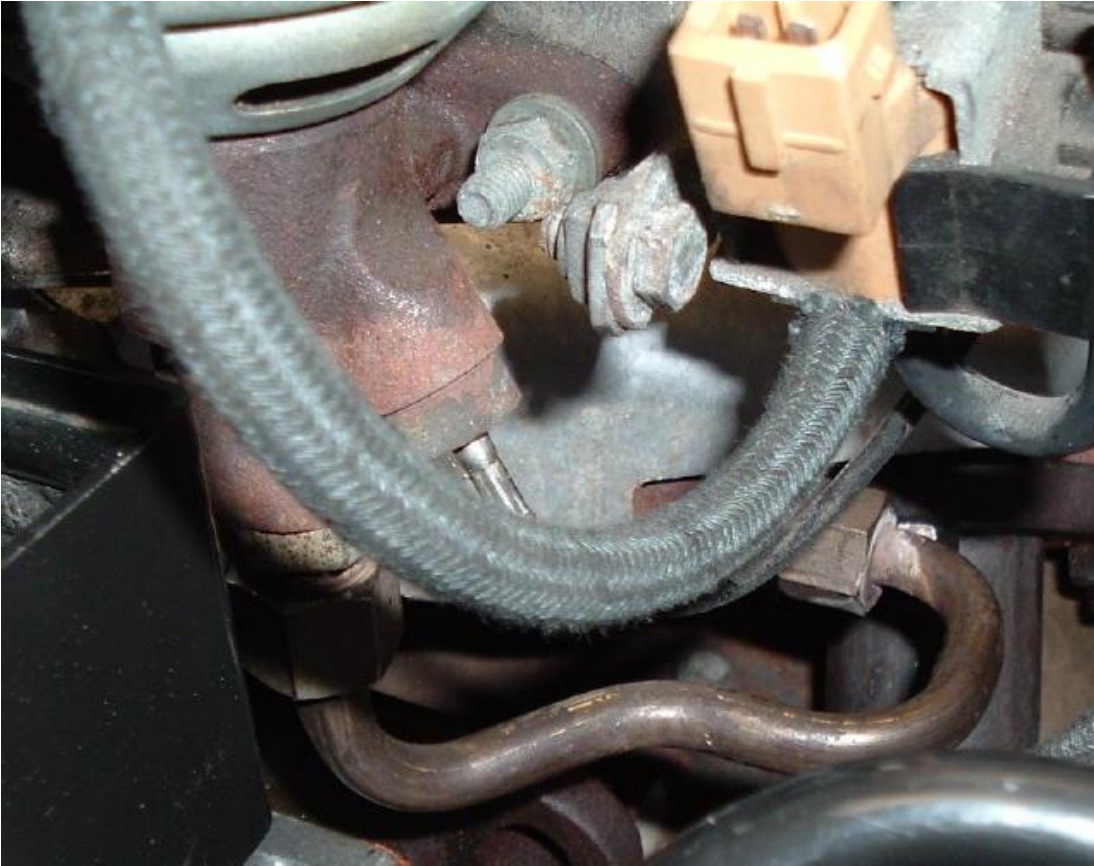
At this point the system is being held only by the tube that connects the bottom of the valve to the exhaust manifold. If your repair job does not include removing the head or exhaust manifold, then you can leave this tube connected. You may possibly have to loosen one end of it so that it might swing back away from the valve cover a little bit.

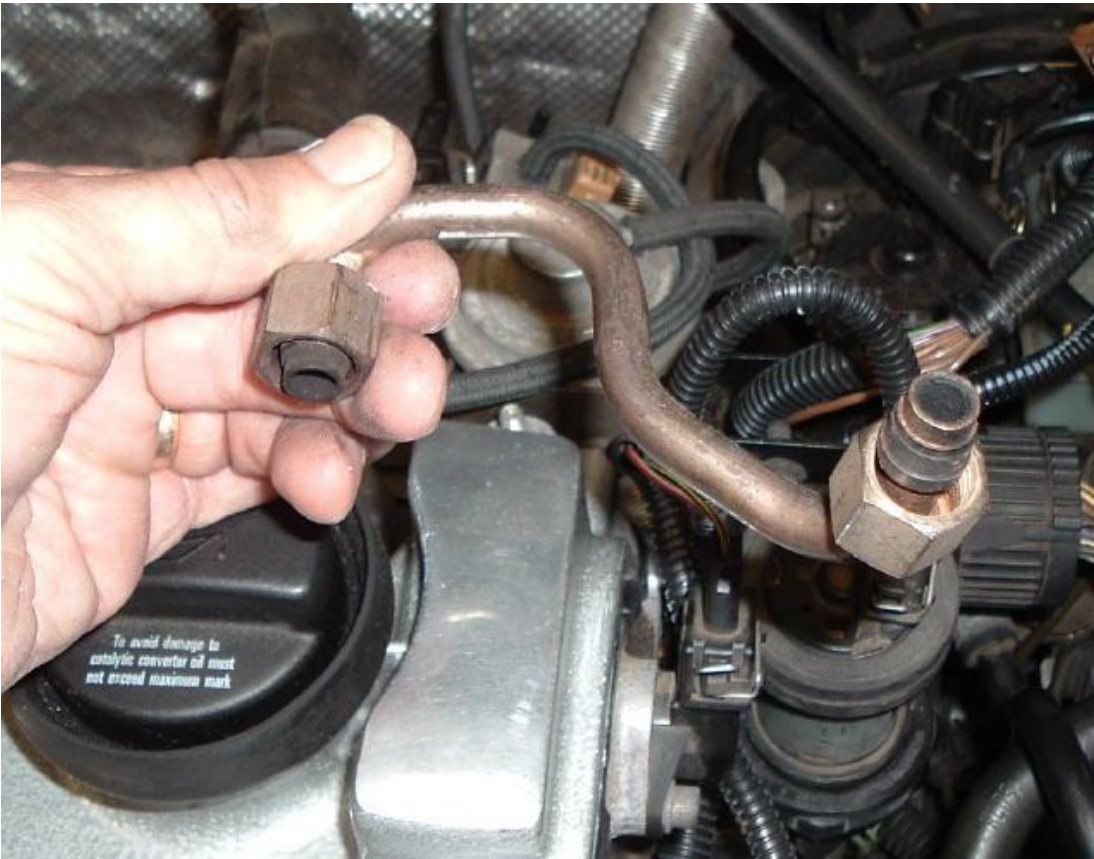
The valve cover can be removed now. If you need to actually remove the EGR valve, first disconnect the vacuum hoses and electrical plugs if not already done. Mark the hoses or make notes to help you reconnect them to the right places later. Then remove the exhaust tube.

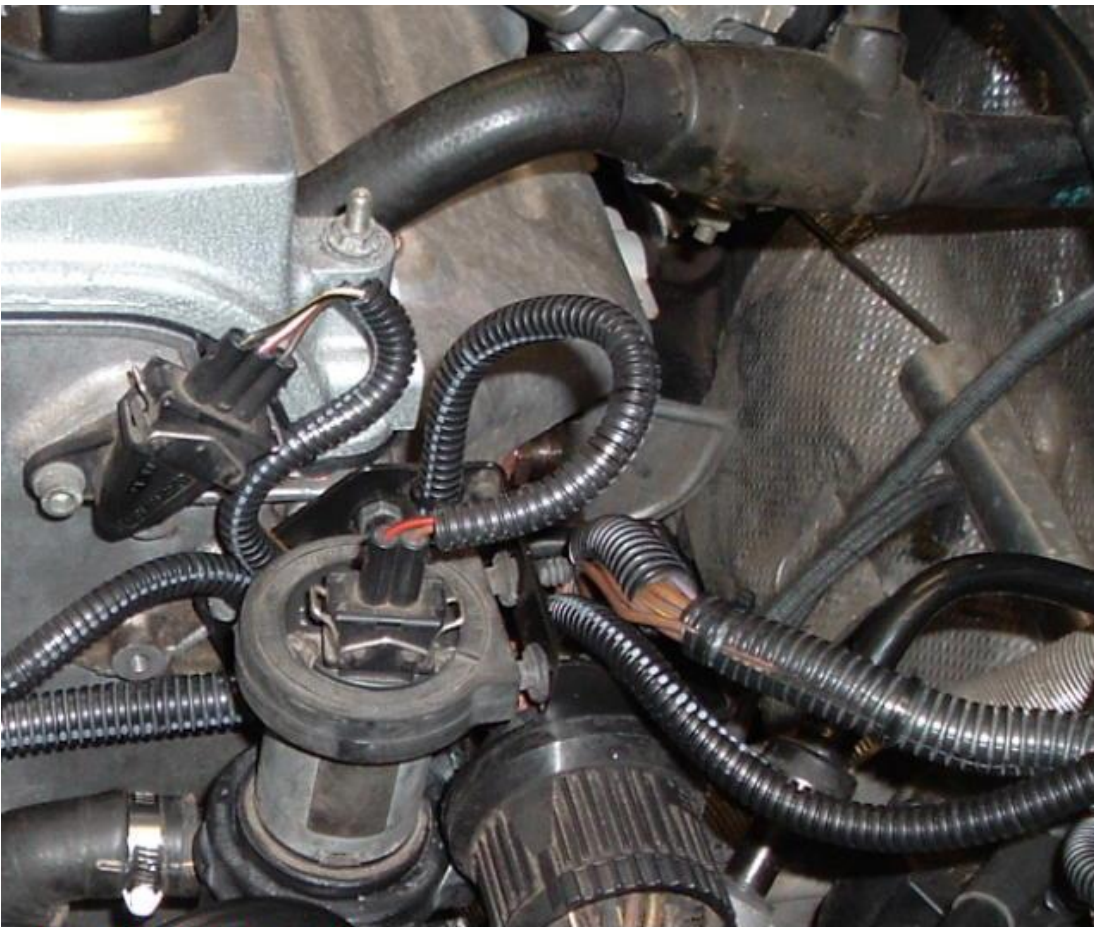
Here is the back corner of the motor sans EGR.

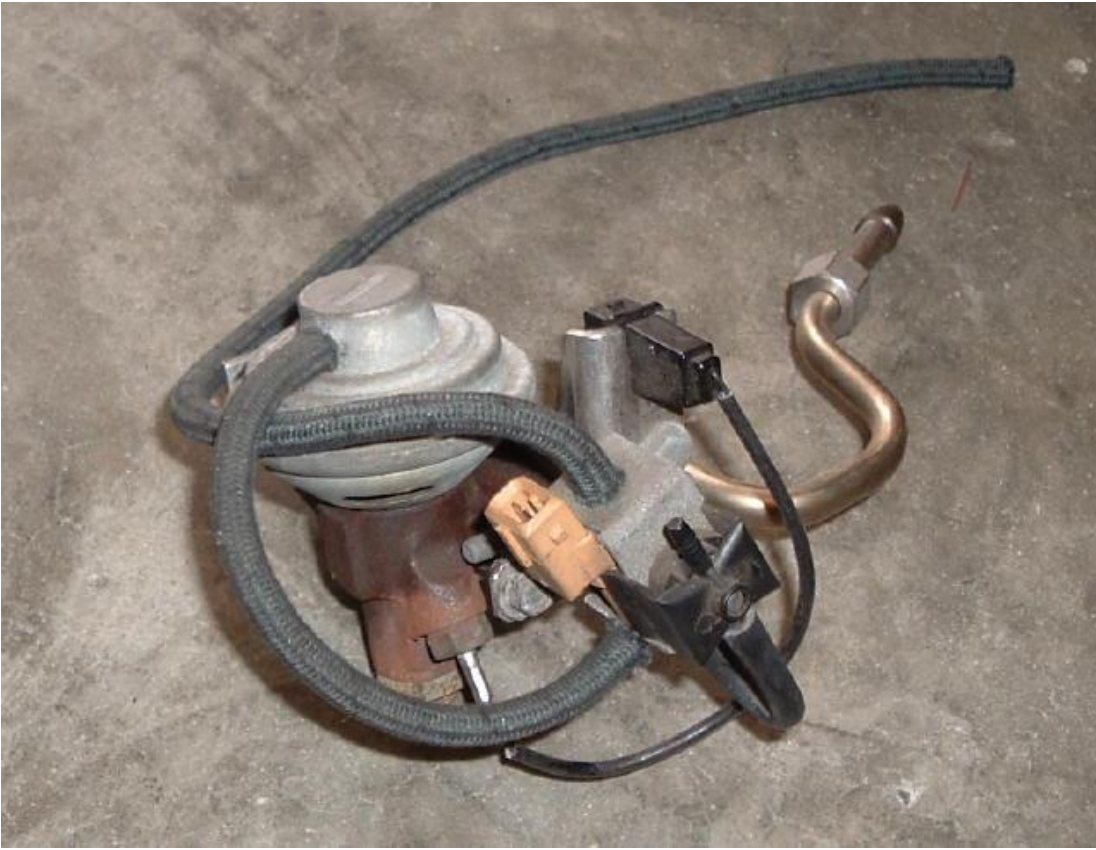
This is the EGR assembly as I removed it from my car.

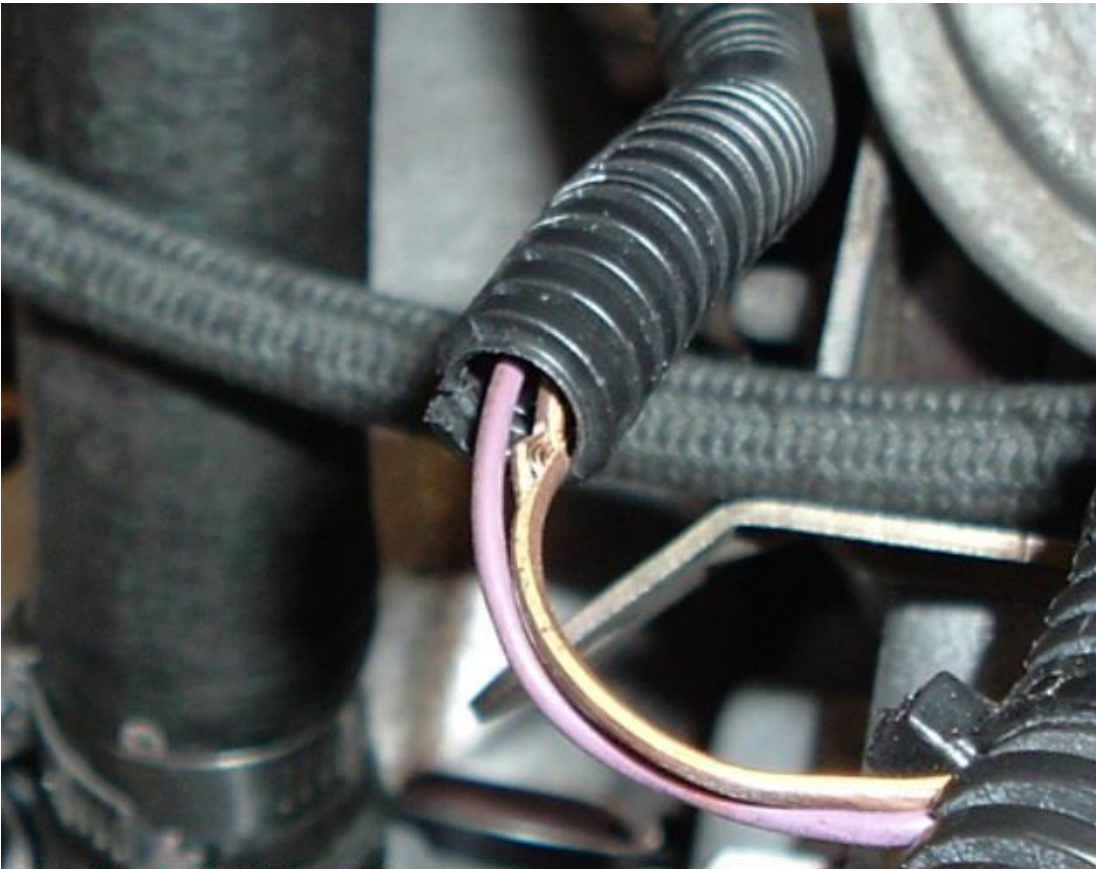
With the EGR system disconnected or out of the way, you can swing the engine harness back up behind the motor if that will get it out of your way. Be very careful handling the wiring. Engine heat makes wires brittle and you get insulation cracks like this one.

You will notice that I have covered most of my harness with pieces of nylon split loom. The original friction tape wrapping was crumbling into dust and the wiring was in danger. This should be done to prevent having to buy a new engine harness sometime later. Remember that a used harness is going to be old and dry too!

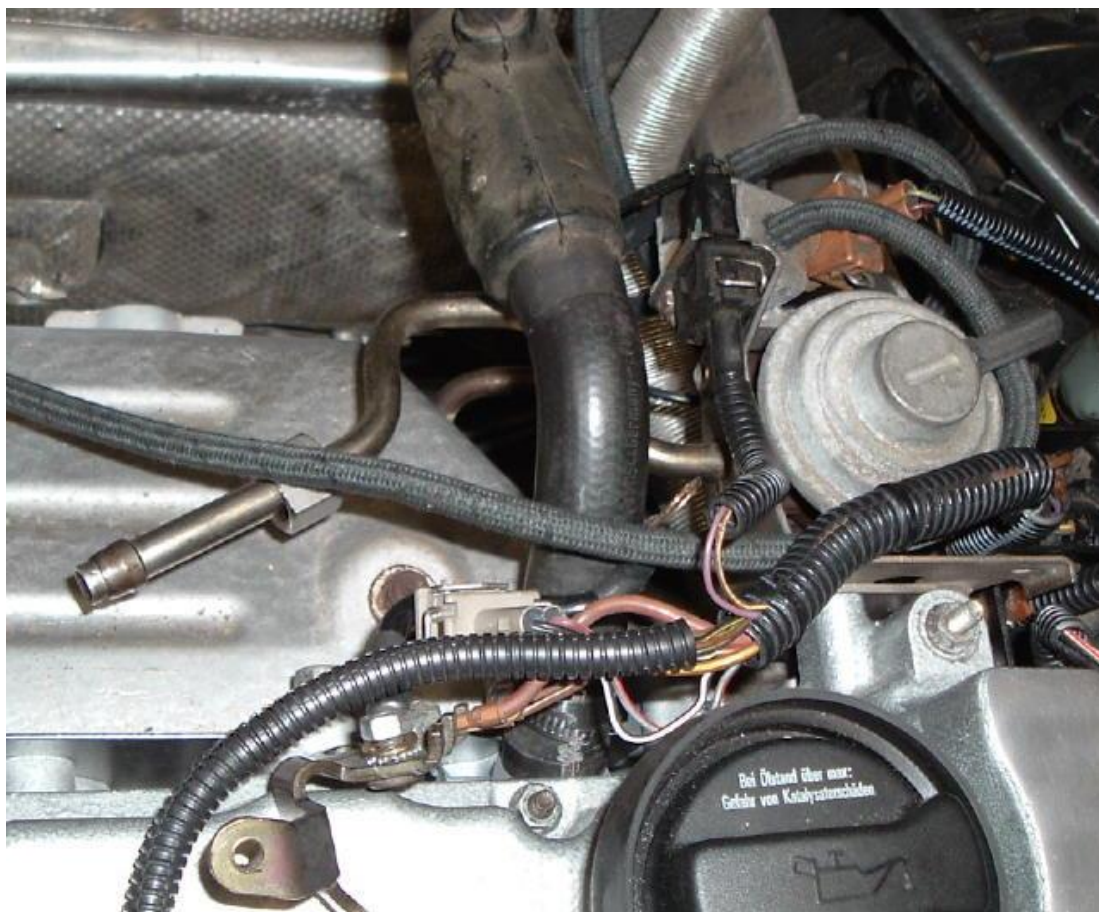
At this point reinstall the exhaust tube if it was removed, or tighten it if loosened. As you begin to install the upper intake, you will have to slide the EGR fitting over the intake tube *before* engaging the other manifold mounting points. The tube cannot be flexed into place afterward.

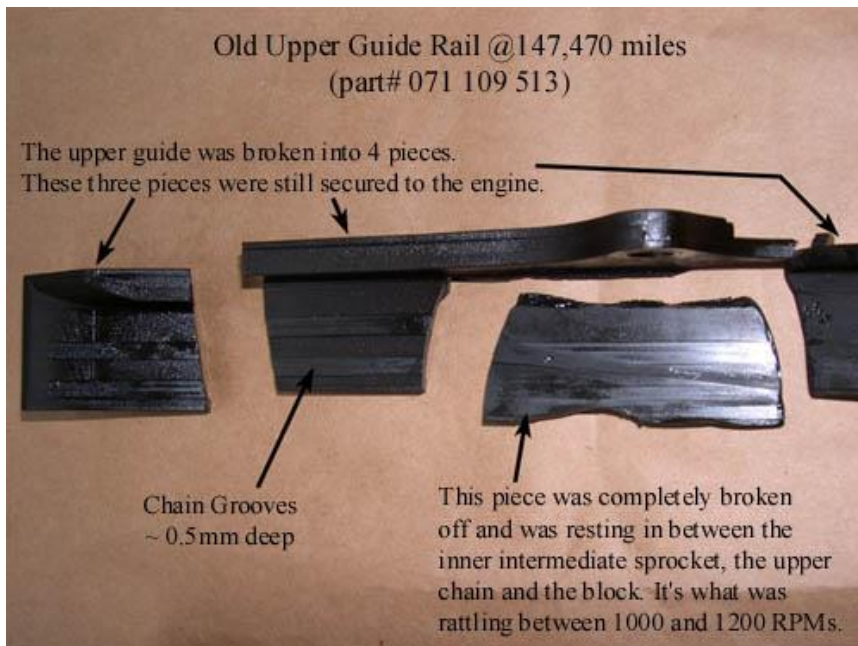
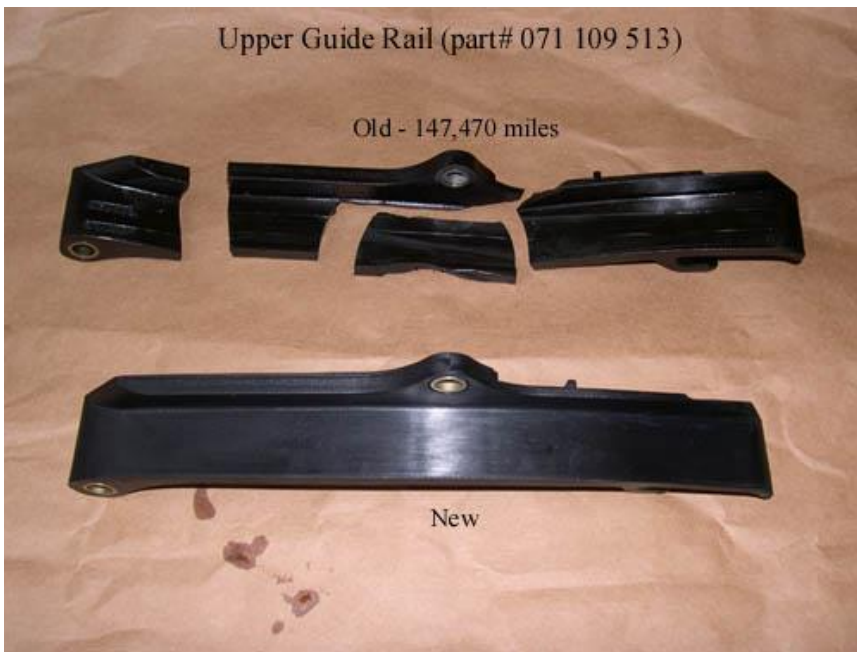
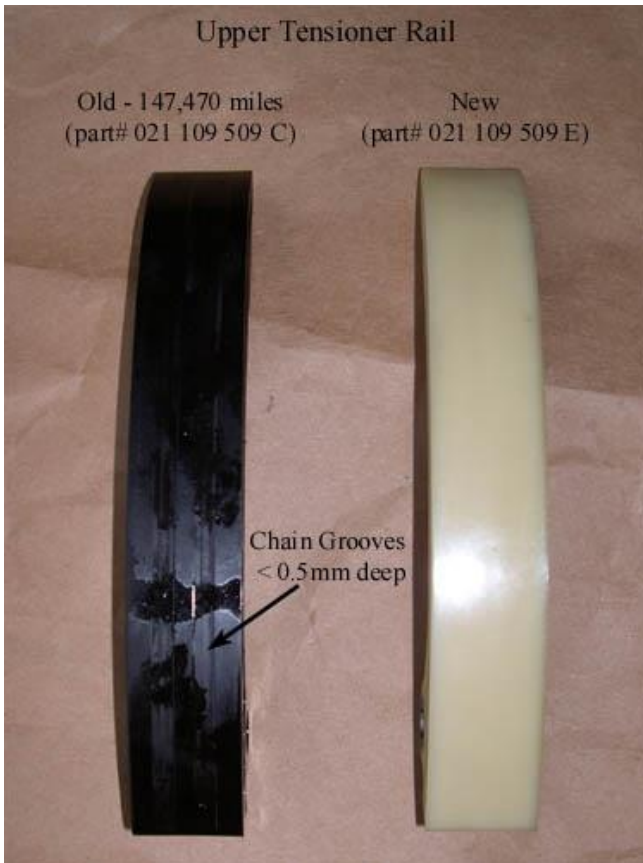
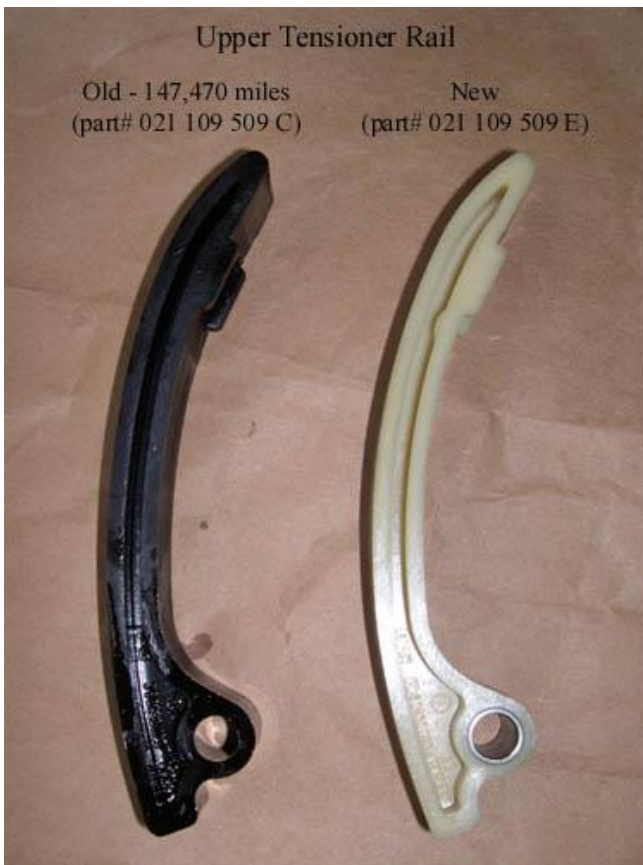
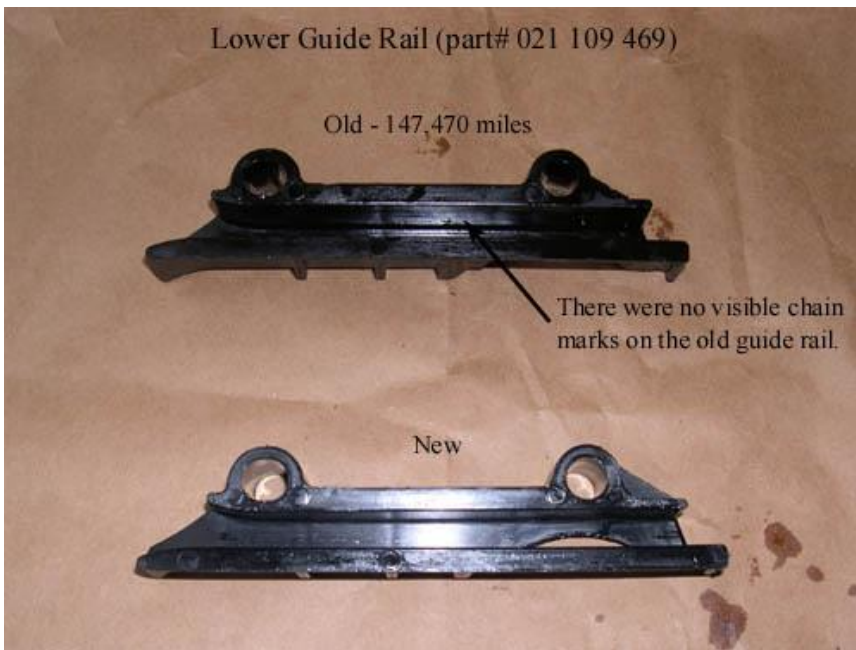
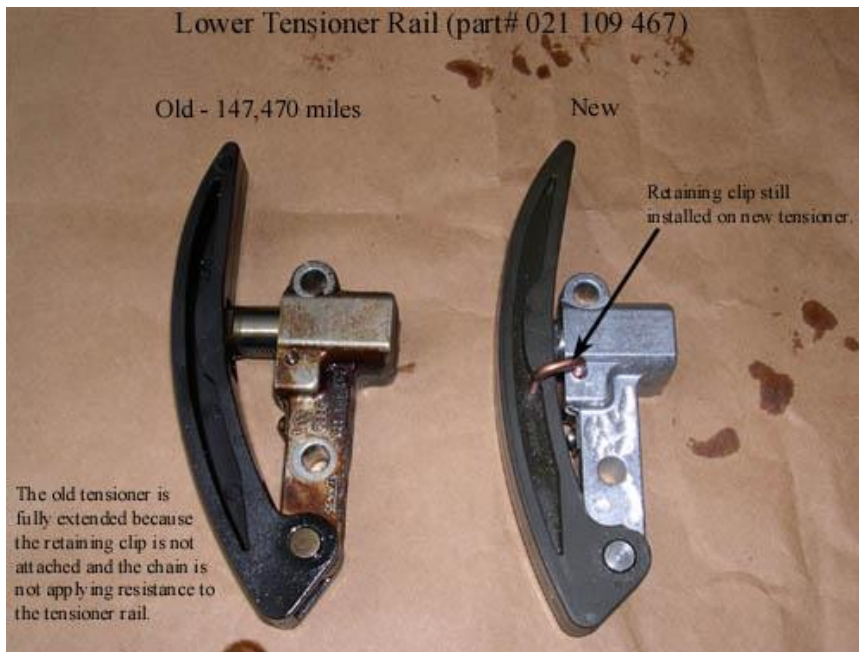
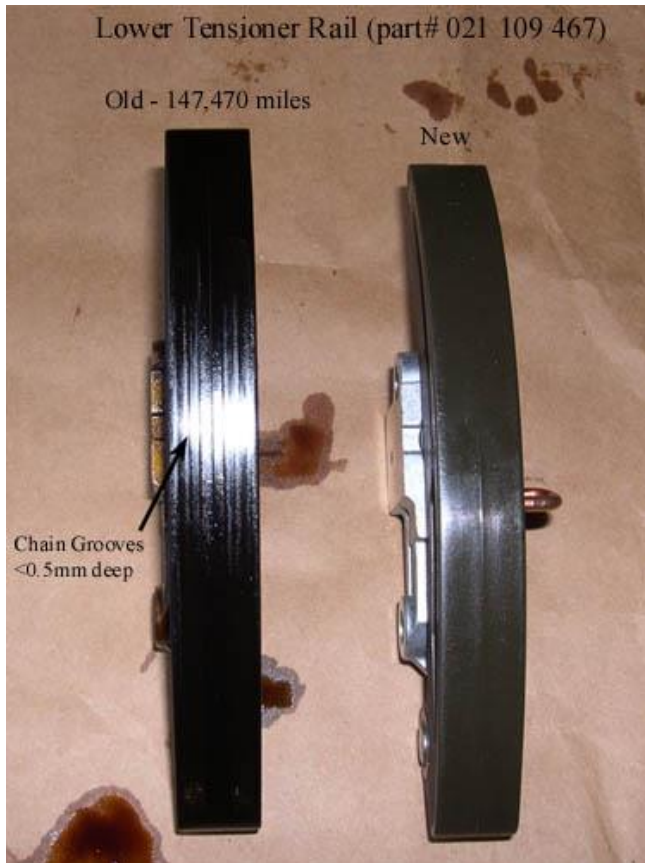
Aside from the upper guide rail that was snapped in a bunch of pieces and was causing a loud rattling noise between 1000 and 1200 RPMs, the rest of the parts show extremely little wear considering they had been in use for almost 150k miles. 🤖

It looks like the newer style upper timing chain parts actually do wear significantly better than the older style parts. Now if only VW could manufacturer an upper guide rail that didn't fail so frequently ... 🚗🔧
