This disassembly instructions is how to gain access to the gears used to fold the tow mirrors of a 2018 GMC Sierra. Note that model years change how the mirrors are assembled, do this repair at your own risk.

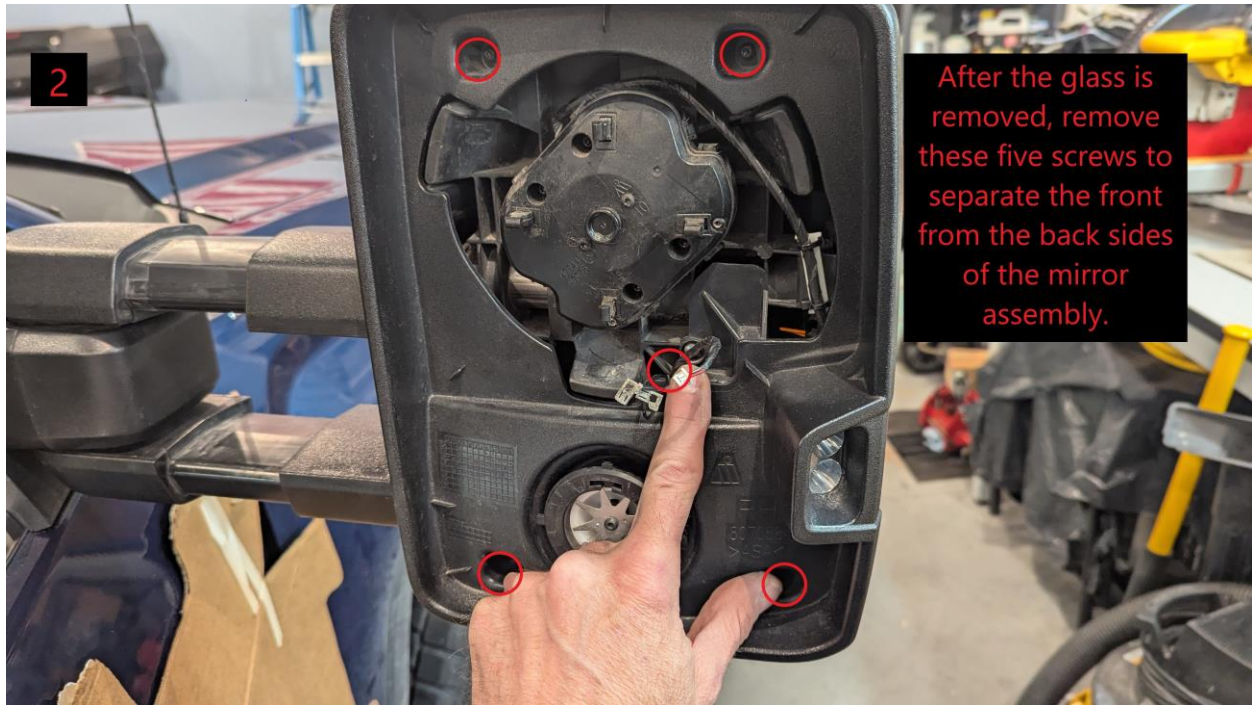
After the glass is removed, remove these five screws to separate the front from the back sides of the mirror assembly.

2. Remove the 5 screws noted to separate the front and back half sections of the mirror. Disconnect wires.
3. Remove the upper and lower chrome caps by releasing the tabs all around the perimeter of the chrome caps. Slide mirror out (extend) almost all the way out, until the "C" clip is visible as noted in photo. Remove the "C" clip. Now the mirror can be pulled completely off the end of the support tubes, loosen and guide wires as needed to remove mirror. Some of the wires can remain in place, support the removed mirror.

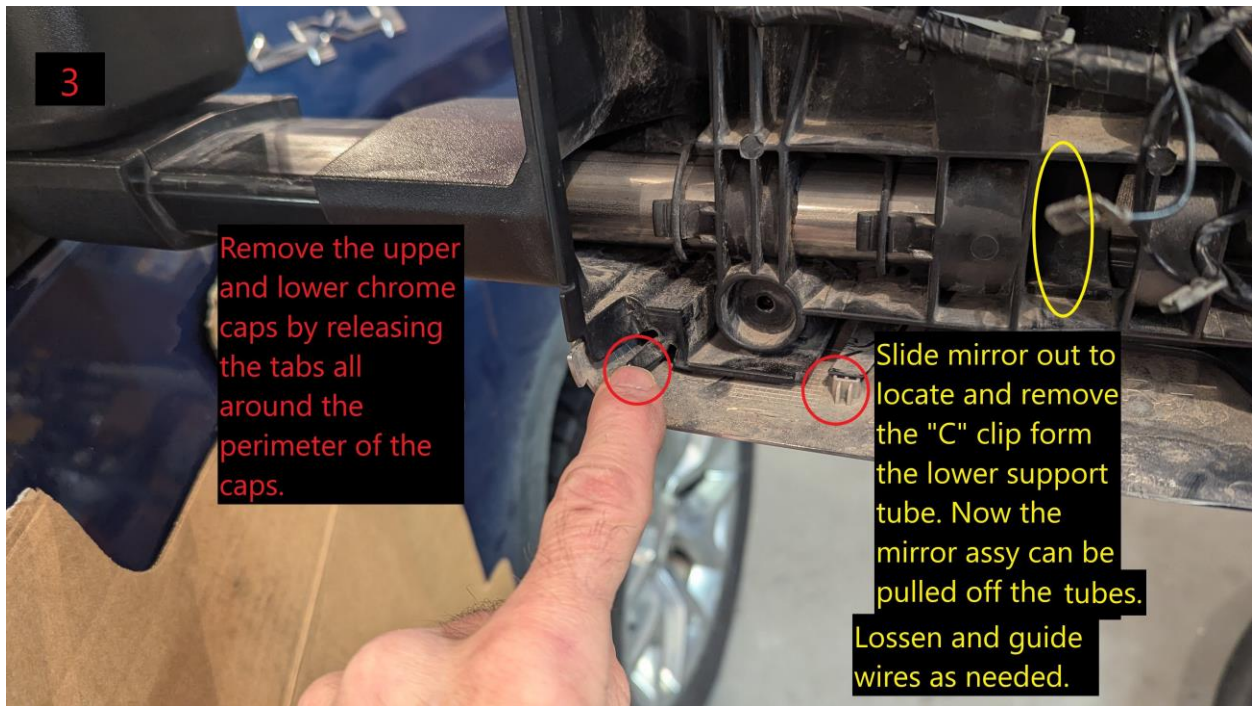
Remove the upper and lower chrome caps by releasing the tabs all around the perimeter of the caps.

Slide mirror out to locate and remove the "C" clip from the lower support tube. Now the mirror assembly can be pulled off the tubes. Loosen and guide wires as needed.

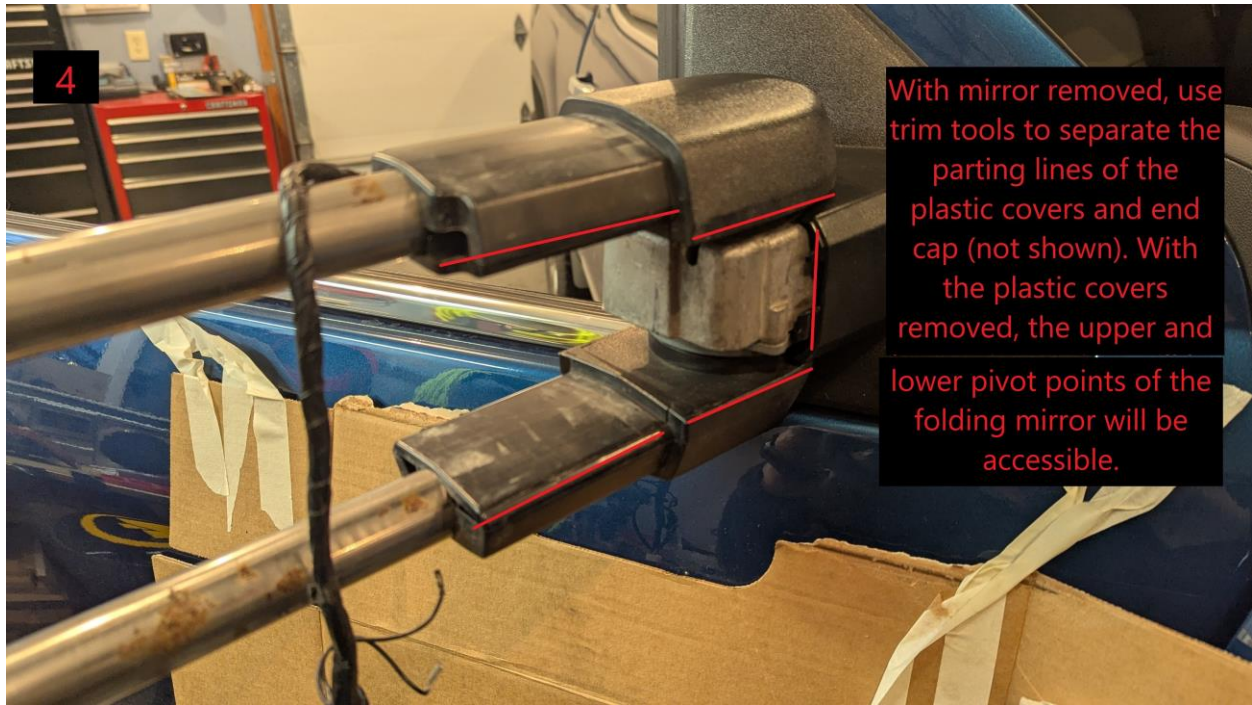
With mirror removed, use trim tools to separate the parting lines of the plastic covers and end cap (not shown). With the plastic covers removed, the upper and lower pivot points of the folding mirror will be accessible.

4. Using trim tools, separate the parting lines of the all the remaining plastic materials as shown, (five pieces in total) to gain access to the upper and lower pivot points for the folding mirror.

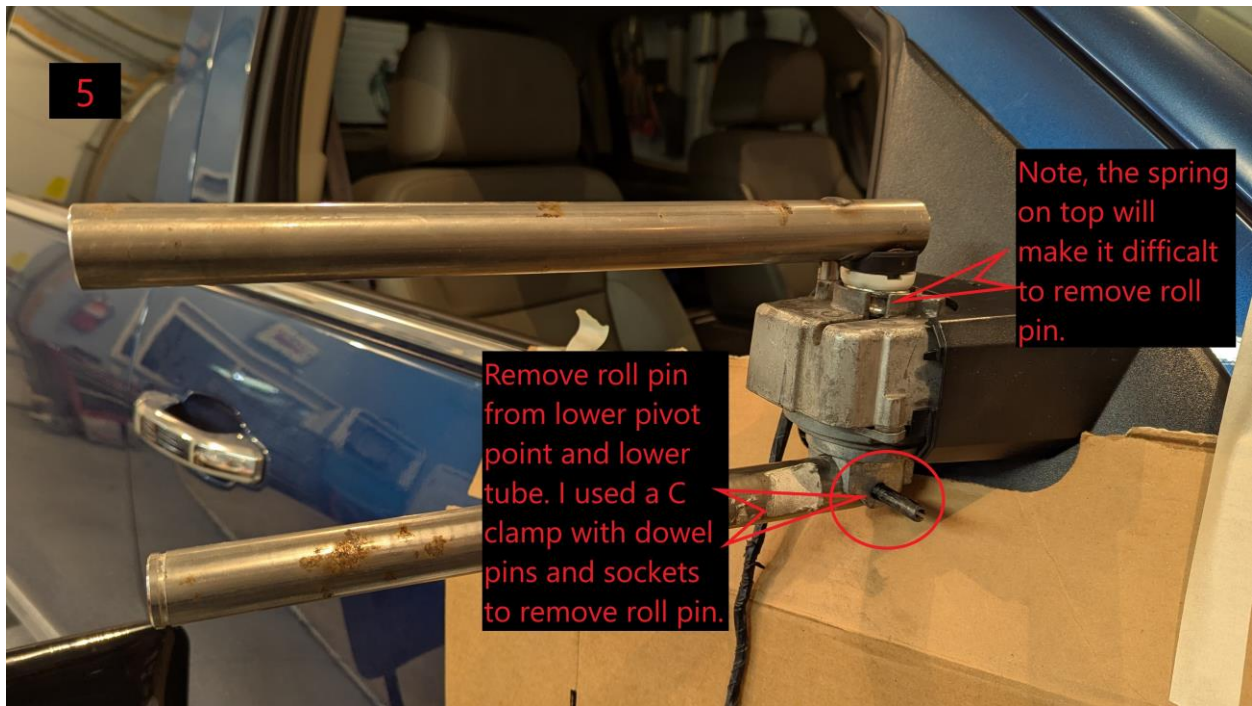
Remove roll pin from lower pivot point and lower tube. I used a C clamp with dowel pins and sockets to remove roll pin.

Note, the spring on top will make it difficult to remove roll pin.

5. Remove the roll pin as noted. I used a C clamp with push pins and sockets to remove the roll pin. The spring located on the upper side of the pivot point make it difficult to remove the roll pin, especially when the roll pin is almost all the way out.

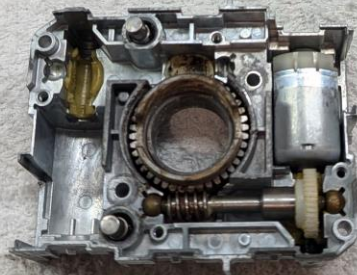
Clean up all parts,  
remove old grease  
and any corrosion.  
Now replace the  
plastic gears with  
brass as per  
[GruvenParts.com](http://GruvenParts.com)

10. Remove the remaining four small screws and separate the case halves. Clean up all parts, remove old grease and any corrosion. Now replace the broken or damaged plastic gears with the brass gears as per GruvenParts.com instructions.

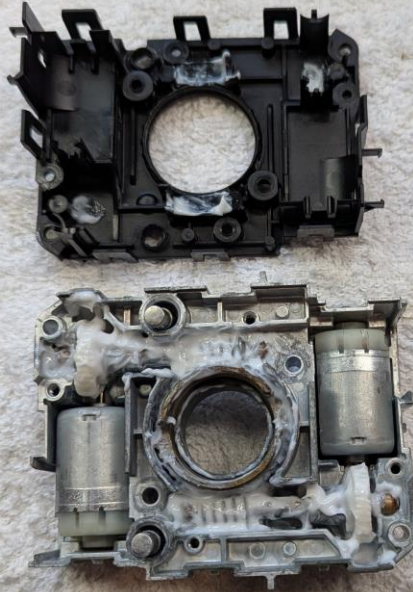
12

Reassemble drive assemble (brass gears not shown) and coat all gears, worm gears and mirror pivot shaft with grease. I used extreme low temp Molykote 33 light grease.

11. Extreme low temperature Molykote 33 light grease.
12. Reassemble the drive assembly (brass gears not shown), coat all gears, worm gears and mirror pivot shaft with grease.

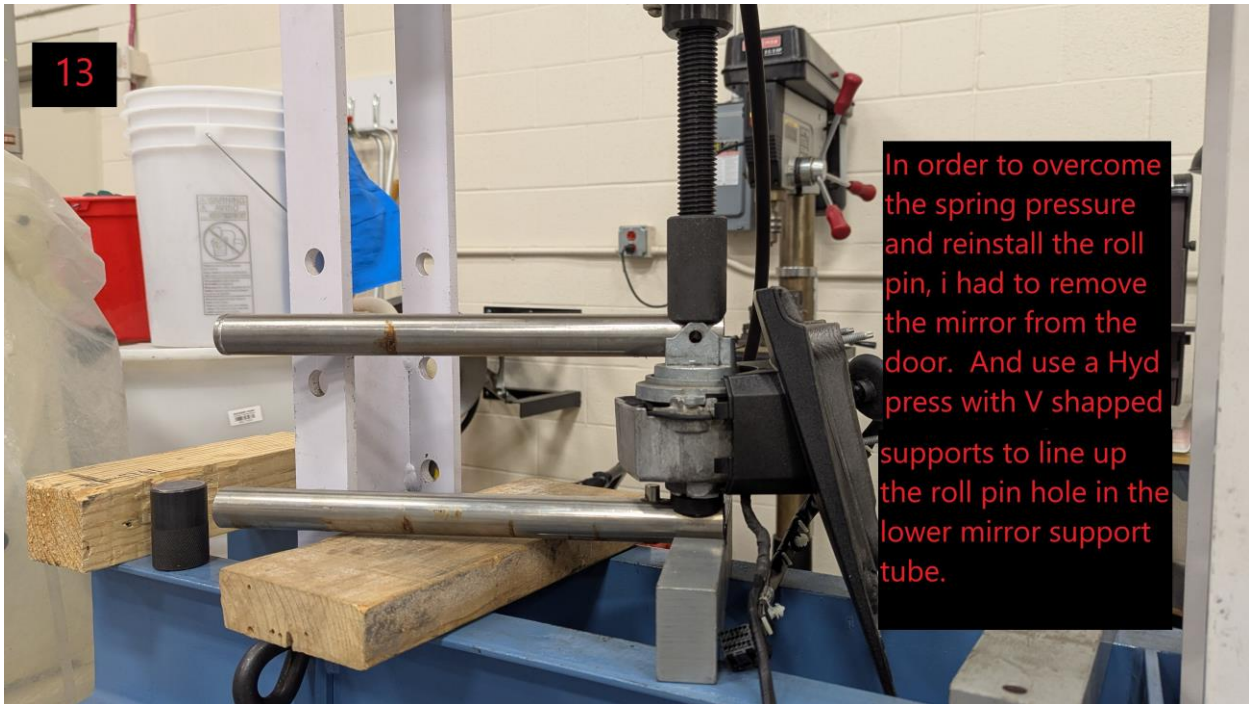
13

In order to overcome the spring pressure and reinstall the roll pin, i had to remove the mirror from the door. And use a Hyd press with V shapped supports to line up the roll pin hole in the lower mirror support tube.

13. A difficult part of the reassembly was to reinstall the roll pin in the support tube, because of the strong spring. I had to remove the whole mirror from the door and use a hydraulic press with V block supports to hold in place. Again using a C clamp to press the roll pin into place.

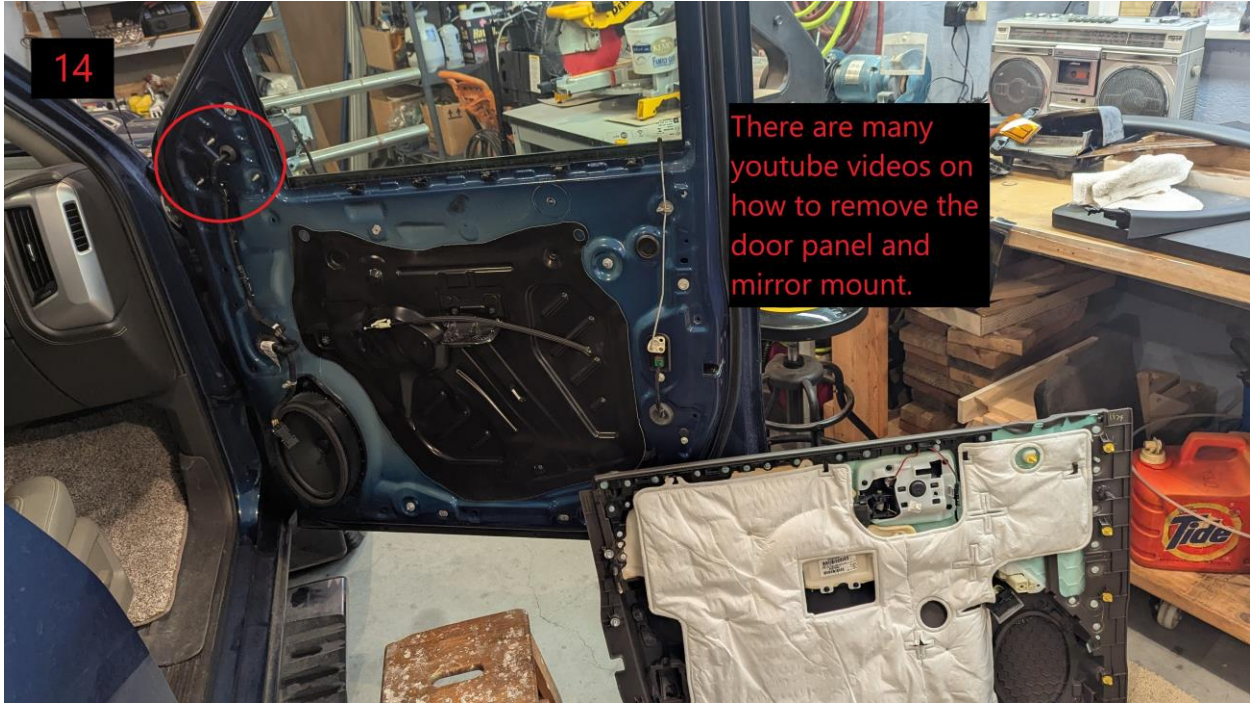
14

There are many youtube videos on how to remove the door panel and mirror mount.

14. Door panel removed to access the four mirror mount nuts.
